TOPOGRAPHIC MONITORING OF A WATER TANK IN THE WIDENING WORKS OF EIXO NORTE-SUL HIGHWAY IN LISBON

Abstract: A monitoring necessity for a water tank in Lisbon originated in the widening work of the Eixo Norte-Sul highway, which involved excavation near the tank. As the excavation could affect the tank's safety and the water supply service, the owner (EPAL – Empresa Portuguesa de Águas Livres) and the employer (EP – Estradas de Portugal) agreed on the installation of a topographic monitoring system. This paper describes the processes in the topographic monitoring of the water tank, and stresses the importance of the installed system. The use of the sub-system for vertical displacement determination as a warning system is also focused. Due to the complexity of the works and an unexpected behaviour of the structure, the integration of the results of the topographic monitoring with the geotechnical instruments was critical in the analysis, understanding and validation of the results.

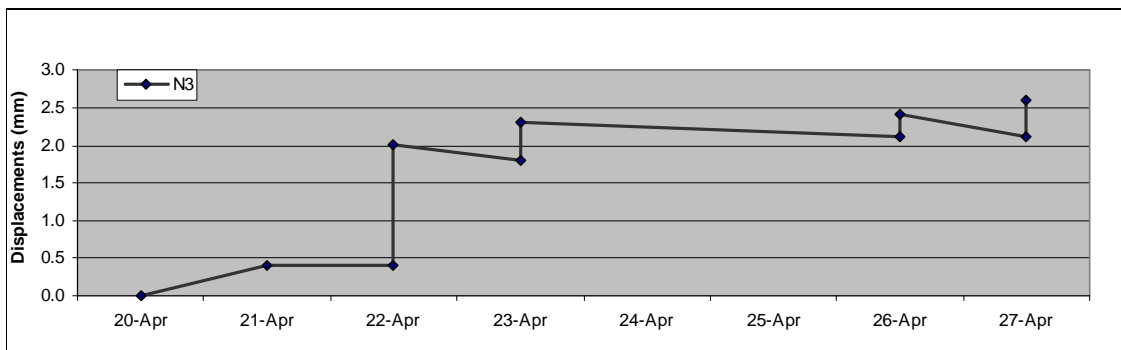
All analysis, for the different kinds of instrumentation, were done in an integrated way. Noteworthy were the positive values of vertical displacements obtained by levelling for the N3 mark in L3 epoch (corresponding to April 22, 2005), as shown in Figure 7.

Figure 7 –Vertical displacements of N3 mark

N3 mark is part of the set of marks closest to the excavation site. For the remaining instrumentation significant displacements were not observed in the same epoch. A vertical displacement (uplift) of approximately +2.0 mm was detected. It was considered by supervisors as an alert value, so works were interrupted for several weeks. When the

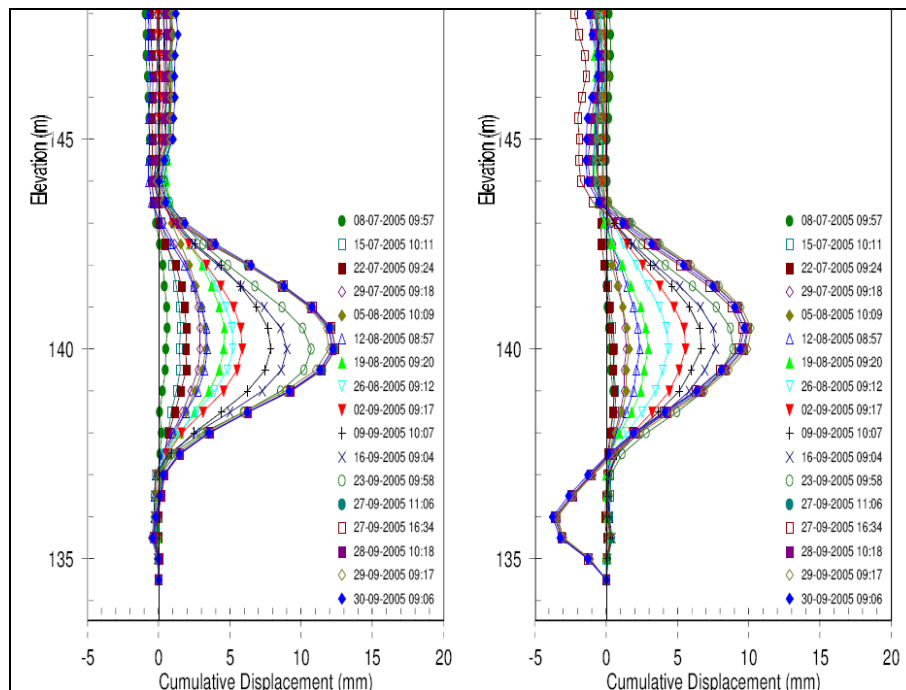
Only in early August 2005 the horizontal displacement subsystem corroborated the values of vertical displacements, and it was no earlier than the end of that month that the geotechnical instrumentation, in particularly the inclinometers, detected these displacements (Figure 8).

Figure 8 –Inclinometer I3 value.

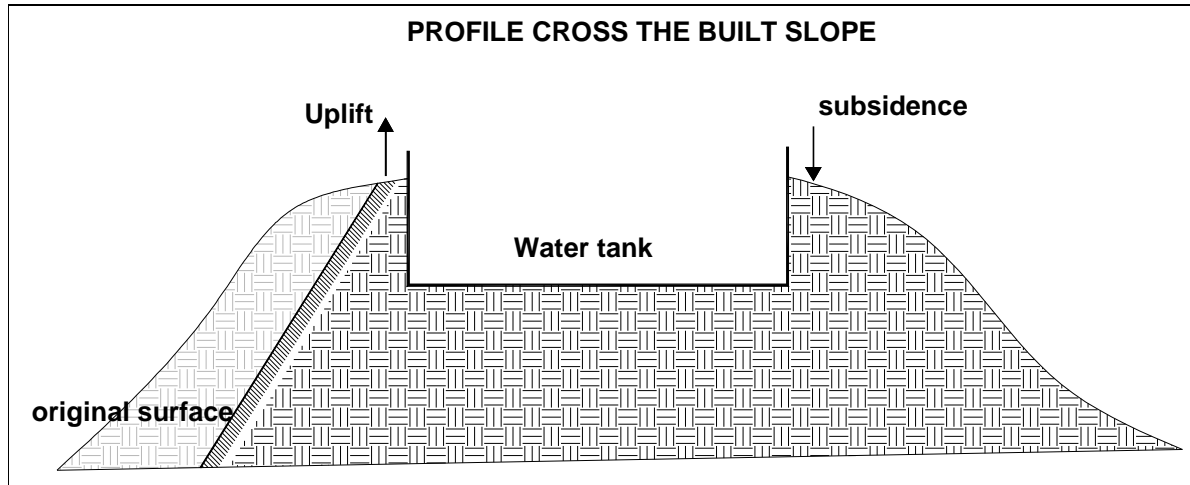
excavation of the slope was resumed, no abnormal results were detected in the first sessions. However, with the increase in excavation depth, re-emerging uplift in marks closest to the slope and subsidence in furthestmost marks were noticed, suggesting the rotation of the tank around an axis perpendicular to the plane of the slope.

Figure 9 – Displacement description observed by the vertical topographic subsystem.

The analysis of displacement readings observed on the instrumentation system installed, were explained by the team, as the result of the excavation done on the natural slope and due to the presence of a silt sandy layer under saturated conditions, at 16 m depth that created a rotational landslide. When this saturated silty layer was intercepted by the excavation, the water started to flow and it washed very quickly the fine material, increasing the landslide phenomenon. The geological drilling survey done nearby the inclinometer I3, confirmed this interpretation. The solution projected by the geotechnical expert team to stop the landsliding was to shotcrete and install drain pipes on the slope of excavation, in order to stop the fine material wash. Figure 10 shows the slope excavation and the actual situation after construction conclusion. After conclusion works, all observed values stabilized in all types of instruments. As a preventive measure, the topographic monitoring system was still in operation until January 2007, although less frequently.

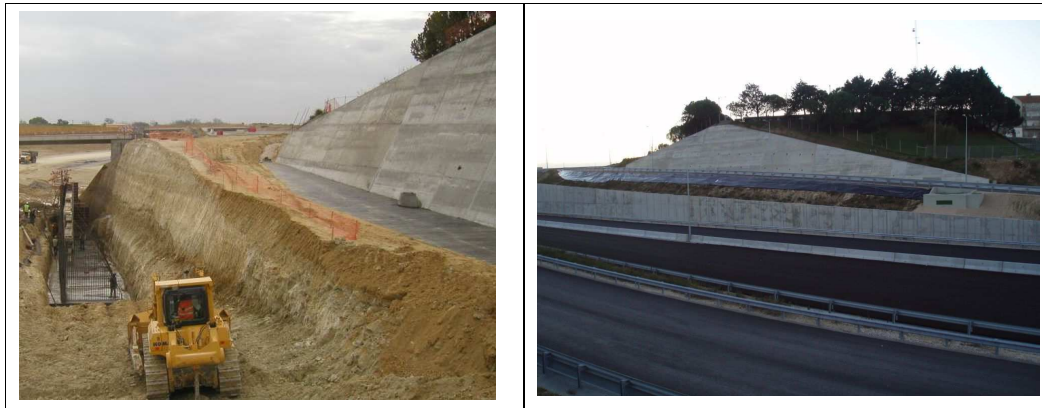
Figure 10 – Photo of the site during and after final works conclusions.
