Hydrographic Survey of the River Drava Branches in the Process of Revitalization, Flood Control and Morphological Monitoring

Dino DRAGUN, Ana GAVRAN and Vedran CAR, Croatia

FIG Congress 2014
Engaging the Challenges - Enhancing the Relevance
Kuala Lumpur, Malaysia 16 – 21 June 2014

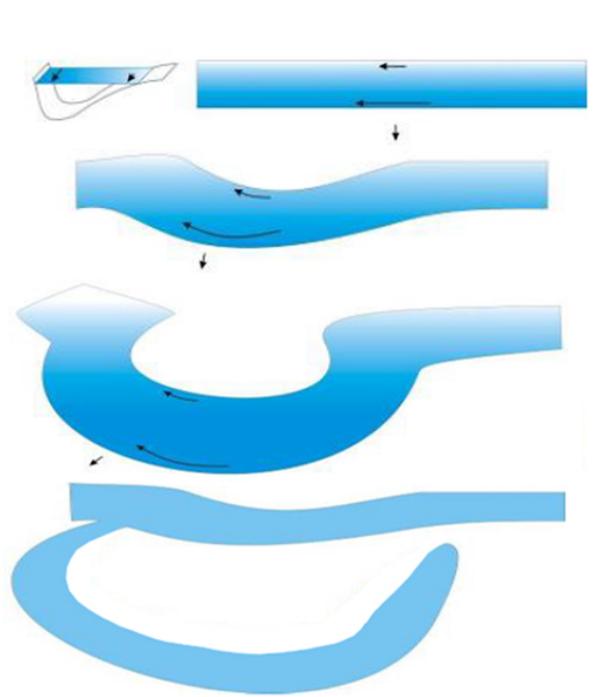
Figure 1. River processes – branch formation

Along the riverbank where the water is deeper, and thus faster, there is increased riverbank erosion. On the other riverside, the water flows slowly and leads to the deposition of sediment. The consequence of this action on the river channel is that there are more and more twists until the big curve (meander) river finally breaks through and creates a parallel short channel. Eventually longer branch because of its lower slope and slower flow becomes covered by sediment and forms a separate river stream (figure 1). The Drava River's branches are some of the last remaining river ecosystems of Europe and home to numerous endangered habitats and species. With the deteriorating river health and many species in severe risk of extinction, these rivers deserve special attention and protection measures. (Grlica 2008)

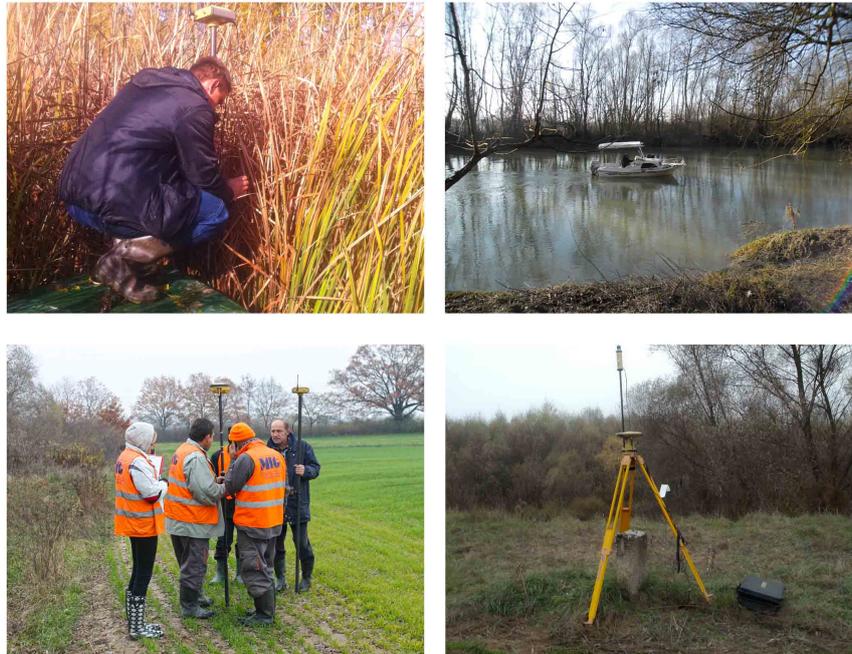
Figure 3. Survey of the Drava River branches

A Base station (Figure 3) was set up above the existing geodetic points along the Drava River, while the rover and echo sounder (immersed 0.32 m in the water) were placed on the construction of the side of the vessel. By placing a RTK antenna and echo sounder in the vertical plane, the presence of lateral offset in the position of the echo sounder calculating was avoided. The main challenge was a hydrographic survey of small depths in the river branches, where the bottom of the river branch is covered with plants and vegetation. For this

reason, we had a large number of redundant measurements, in order to ultimately obtain reliable and accurate depth information. Since bathymetry is performed using acoustic method, it is necessary to measure the sound velocity in water, which is dependent on the temperature and water depth, ranged between 1422 m/s and 1437 m/s. During the hydrographic survey, due to the large amount of precipitation the water level of the river Drava was increased and hydrographic survey of the branches was significantly impeded. We experienced extremely unfavorable conditions during the survey of the Drava River, including submerged piers, sedge and other vegetation, and a large water wave that significantly raised the water level of the river and its branches.

A geodetic survey was performed using a satellite positioning system (GNSS) and where this was not possible, terrestrial measurements were performed with total stations (tachometric method). Specificity of the bathymetric measurement is the integration of the different measurement systems, in order to determine coordinates of the echo sounder and depths in real time. For this purpose we used single-frequency Sonarmiteecho sounder (235 kHz) and Topcon Base and Rover GNSS RTK System. Software package Hypack Max, which is used in this hydrographic survey automatically transform coordinates from WGS84 datum to Croatian Terrestrial Reference System (HTRS96/TM). All of the devices are connected to a laptop PC and integrated in abovementioned software Hypack Max.

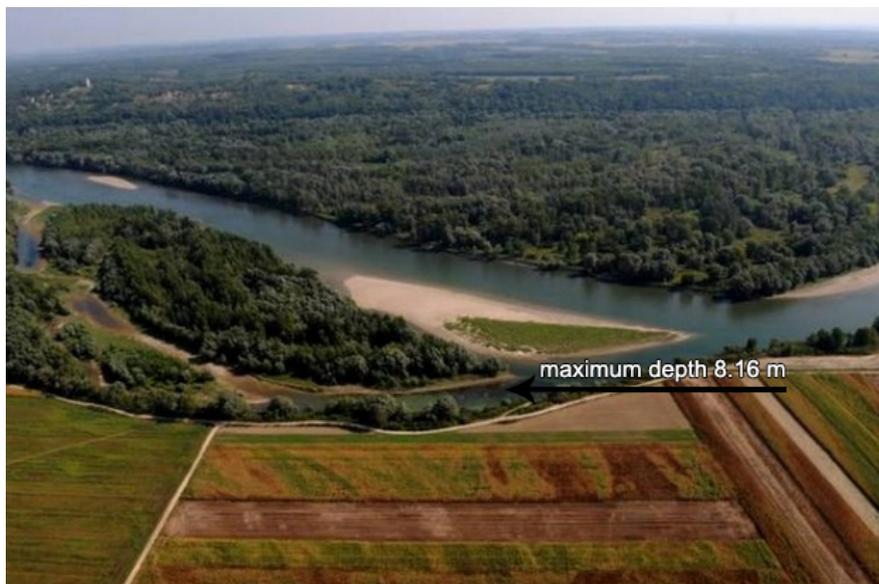
Figure 4. Right bank branch near Legrad

slow down the flow, but it is possible to create short inlets and river branches that are quickly overwhelmed with new sediment deposits. Maximum surveyed depth in this river branch is 8.16 m and its position is shown below in figure 4.

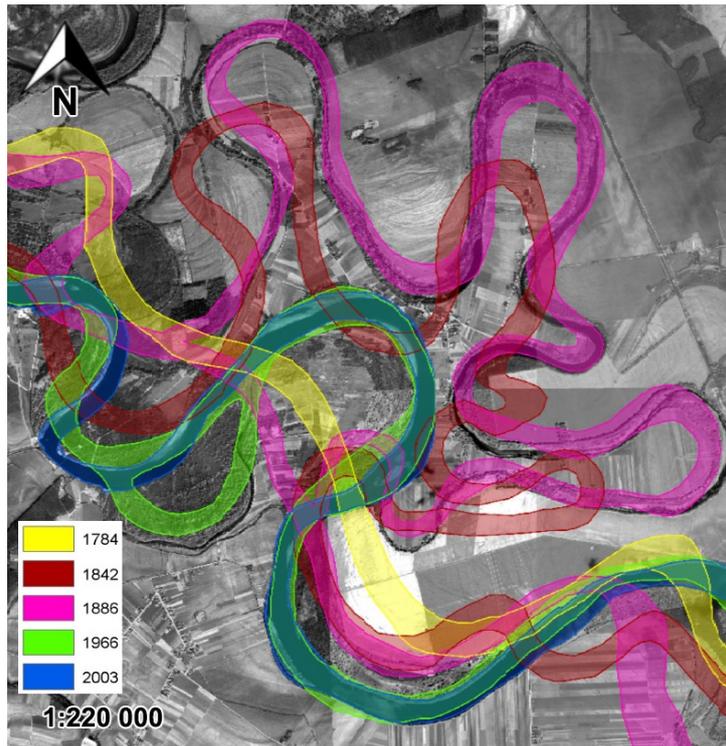
Figure 5. Changing the position of the Drava River during the years (near Križnica)

At a length of 13.5 km the left bank branch near Križnica is the longest branch of these five branches. The research of this survey, in agreement with long-term professional research has undoubtedly demonstrated the necessity to ensure the dressing of fresh water from the Drava River in order to reduce the impact of eutrophication and siltation intensity. The river has changed its course due to various regulatory interventions implemented in the 1820's. These interventions were implemented without a comprehensive plan and had almost no theoretical scientific basis. Further interventions in the period between 1842 and 1966 were designed to shorten the waterway and to improve the protection of the surrounding area from flooding. Finally, in 1966 there was adequate access to regulatory procedures performed, however there is still room for better river channel management, which is discussed in this paper. All of the above resulted in the formation of the Left bank branch near Križnica (magenta color in figure 5), which is, among the other branches, the subject of this hydrographic survey.

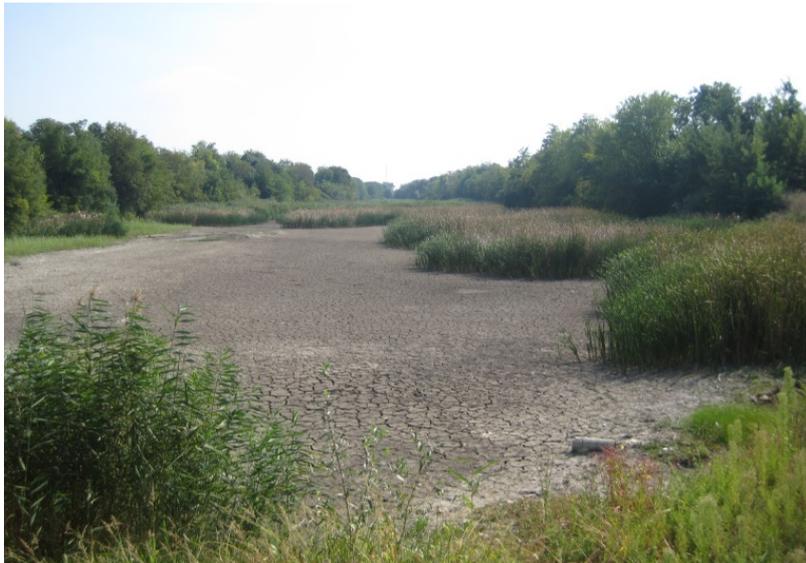
Figure 6. Dried up river branch

Eutrophication is a global problem. In the world there are 415 eutrophic ecosystems, and that number is growing as a result of the growing human population and increased pollution. From the hydrologic point of view, the river branch is characterized by very small flows and unsteady water regime. Ultimately, all this leads to a reduction in the volume of water or its complete disappearance (figure 6) in the river channel which results in reducing the number of specimens of fauna and further settling of all pollutants. Actions and parameters that provide revitalization progress are: water surface management by digging canals and clearing forest vegetation, silt removing, marsh vegetation cleaning and the construction of hydraulic structures, reducing the difference of water level between river channel and river branch.

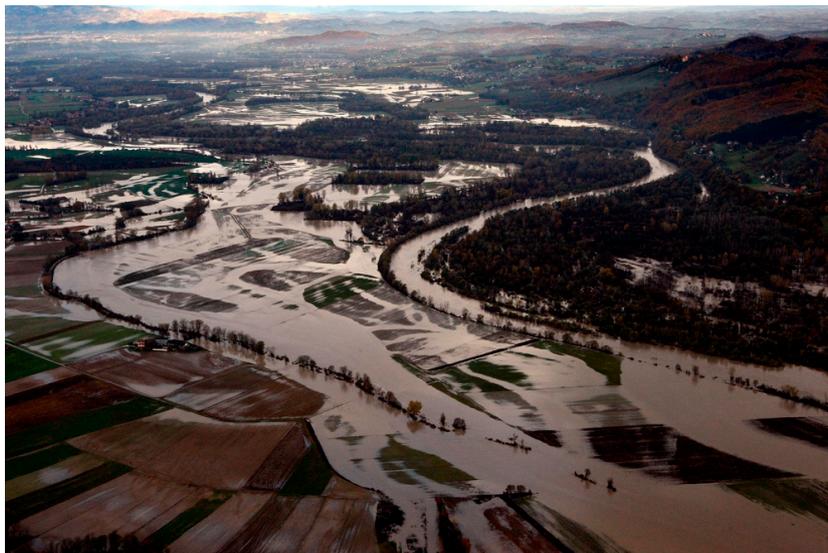
Figure 7. Flood in the upper course of the Drava River, November 2012.

As noted above, every year at least one of the rivers in Croatia has recorded the emergence of new extreme value and meteorological models in future expect even greater changes (Figure 7). This is just another example of why we need to work systematically to improve the system of hydro-meteorological forecasting. Output data of this survey provides information of the river channel configuration and of the maximum volume of water that a river channel can accept. In Croatia, there are natural retentions such as Lonjskopolje and Kopačkirit where part of the floodwaters can be kept. A simple and effective project that is being implemented 'Development of the system for the prediction of floods on the river Drava' will contain a database that will be used to create digital mathematical model of flood forecasting. Databases will inter alia contain the following information: the amount of water discharged by the hydroelectric plants, amount of the rainfall and melting snow in the Alps, geoinformatic and hydraulic models for the Drava's hydrographic stations, morphological monitoring data obtained by hydrographic survey etc.
