APPLICATION OF UAV-BASED LIDAR FOR IDENTIFYING LANDSLIDE AND EROSION AREAS AT CANADA HILL, MIRI, SARAWAK, MALAYSIA

David CHANG Leng Hua, Jaithish JOHN, Edward MUOL, Vijayan V.V. RAJAN, Prakasini S DAVANDRAN, Marelyn Telun DANIEL, Muhammad Syahir SAMSUDDIN, Malaysia

Key Words: LiDAR, Digital Terrain Model (DTM), landslides, erosion

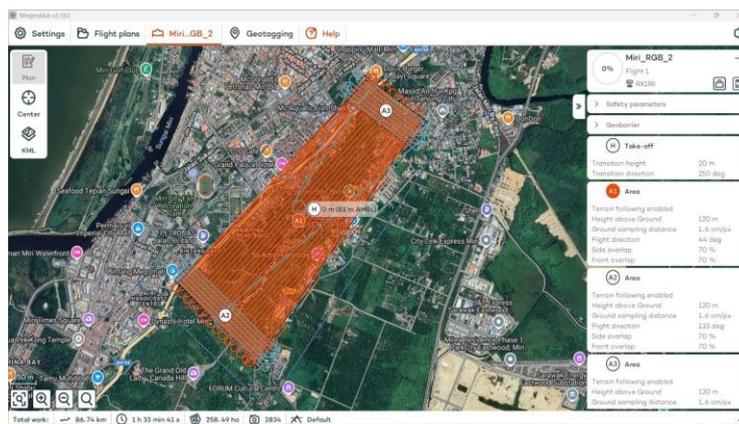
Figure 2: Flight Plan for RGB Photogrammetric Flight

Flight planning was performed using WingtraHub (v2.18.0), with survey parameters optimized separately for the RGB and LiDAR missions to meet their respective data quality requirements (Figure 2 & 3).

The RGB mission was designed to generate high-resolution orthophotos covering the entire Canada Hill study area. Key parameters included:

- Terrain following: enabled
- Flight altitude: approximately 120 m above ground level (AGL)
- Ground sampling distance (GSD): ~1.6 cm/pixel
- Front overlap: 70%
- Side overlap: 70%

- Flight directions: multiple orientations to improve image geometry and reduce shadow effects

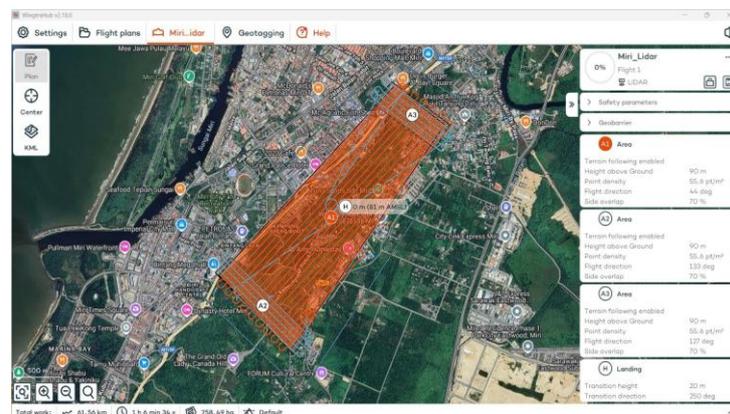
Figure 3: Flight Plan for LiDAR Data Acquisition

A separate LiDAR mission was conducted over the same area to ensure optimal point density and terrain representation. The LiDAR flight parameters were as follows:

- Terrain following: enabled
- Flight altitude: approximately 90 m AGL
- Average point density: ~ 55 points/m²
- Side overlap: 70%
- Multiple flight lines: including different orientations to minimize terrain shadowing and improve ground point distribution

The lower flight altitude and high overlap were selected to enhance point density and ensure reliable ground returns in steep and vegetated sections of the study area.

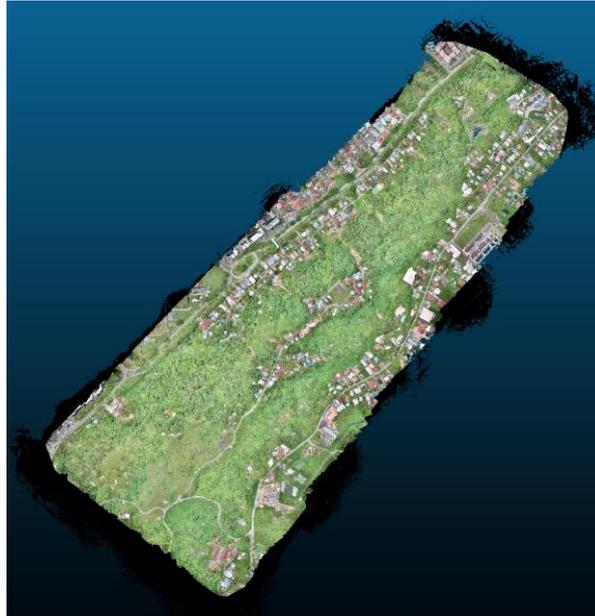
Figure 4: Classified UAV LiDAR point cloud

The UAV LiDAR survey over Canada Hill, Miri produced a dense three-dimensional point cloud covering the entire study area, capturing both terrain and surface features across steep and vegetated slopes. (**Figure 4**) The point cloud exhibits continuous spatial coverage with minimal data gaps, reflecting the effectiveness of the flight design, terrain-following configuration, and high side overlap employed during data acquisition. The LiDAR data clearly resolve variations in land cover, including dense vegetation, built-up areas, road networks, and open ground. Despite extensive tropical vegetation, the point cloud contains a sufficient number of ground returns beneath canopy cover, enabling reliable separation of ground and non-ground points. This is particularly evident in forested sections of the hill where vegetation density would otherwise obscure terrain features in optical imagery alone.

Vertical continuity within the point cloud allows clear differentiation between canopy layers, built structures, and the underlying terrain surface. In urbanized portions of the study area, buildings and infrastructure are well defined, while in vegetated slopes the point cloud demonstrates penetration through foliage to capture ground elevations along ridgelines, hillslopes, and drainage paths. These characteristics are critical for generating an accurate Digital Terrain Model (DTM) in complex terrain.

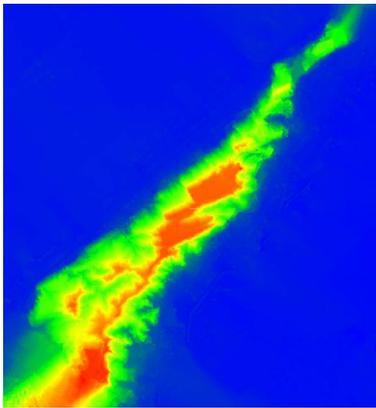
Figure 5: LiDAR-derived Digital Terrain Model (DTM)

The LiDAR-derived Digital Terrain Model (DTM) (**Figure 5**) provides a detailed representation of the bare-earth surface across the Canada Hill study area, successfully resolving terrain variability despite dense vegetation cover. The DTM captures the elongated ridge morphology of Canada Hill, with elevated terrain forming a continuous crest and progressively lower elevations extending downslope toward the surrounding urban and low-lying areas.

The terrain model clearly delineates steep slopes along the flanks of the hill, as well as gentler gradients in localized depressions and valley-like features. Subtle variations in elevation are evident along hillsides, reflecting micro-topographic expressions such as shallow scarps, concave slope segments, and small incised channels. These features are not readily identifiable from optical imagery alone but are distinctly preserved in the LiDAR-derived terrain surface.

Comparison with the orthophoto highlights the advantage of the DTM in isolating ground morphology beneath dense tropical vegetation. While the orthophoto shows continuous canopy cover across much of the study area, the DTM reveals underlying slope breaks, linear depressions, and irregular surface textures that are indicative of geomorphological processes. In built-up areas, the removal of structures during ground classification results in a smooth yet topographically consistent surface, allowing the terrain to be analysed independently of anthropogenic features.

The color-coded elevation representation further emphasizes relative height differences across the study area, with higher elevations concentrated along the central ridge and lower elevations toward the periphery. This elevation contrast supports subsequent derivation of slope, curvature,

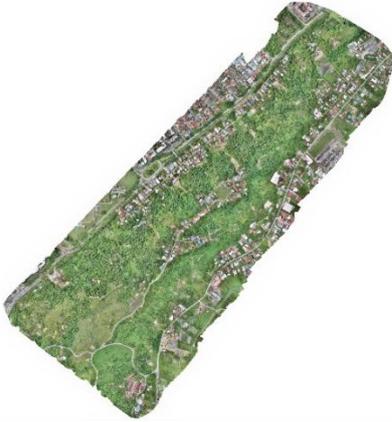
Figure 6: High-resolution Orthophoto

The integration of the DTM (**Figure 5**) with the high-resolution orthophoto (**Figure 6: High-resolution Orthophoto**) enabled the identification of landslide features across the Canada Hill study area. While the orthophoto provides detailed visual information on land cover and surface conditions, the DTM reveals the underlying terrain morphology that is essential for detecting slope failures, particularly in densely vegetated areas. Several zones exhibiting geomorphological characteristics consistent with landslide activity were identified from the DTM. These include distinct slope breaks, arcuate and linear scarps, uneven and hummocky surface textures, and localized depressions indicative of displaced material. In many cases, these features are subtle or entirely obscured in the orthophoto due to continuous vegetation cover, highlighting the advantage of LiDAR-based terrain representation for landslide detection in tropical environments.

The orthophoto was used to corroborate DTM-based interpretations by identifying surface expressions associated with instability, such as exposed soil patches, disrupted vegetation patterns, bare-earth scars, and alignment of downslope disturbances. In areas where vegetation regrowth has occurred, the orthophoto alone does not clearly indicate slope failure; however, the DTM reveals persistent terrain irregularities that suggest past or ongoing landslide processes. Landslide features were most commonly observed along steep hillslopes adjacent to drainage pathways, road cuts, and areas of slope modification. These locations exhibit a combination of steep gradients and disrupted terrain geometry, consistent with zones of increased susceptibility to slope failure. The spatial correspondence between DTM-derived slope breaks and orthophoto-observed surface disturbances strengthens the interpretation of these features as landslides rather than natural undisturbed slopes.

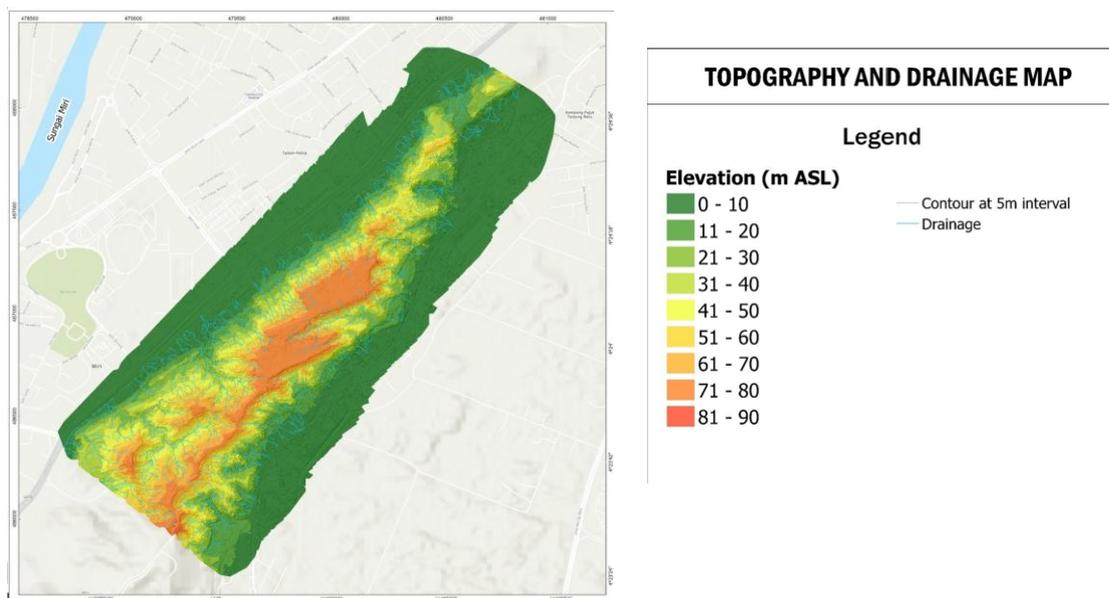
Figure 7: Topography and drainage map derived from the LiDAR DTM, highlighting elevation classes and surface drainage networks.

The LiDAR-derived DTM enabled detailed mapping of surface drainage patterns and erosion-related terrain modification across the Canada Hill study area. **Figure 7** shows the topography and drainage map reveals a well-defined elongated ridge, with elevations increasing toward the central crest and decreasing toward the surrounding lowlands. This elevation gradient strongly controls surface runoff pathways and erosion processes. (Figure

Dense drainage networks are observed along the flanks of the hill, particularly in areas with moderate to steep slopes. These drainage lines correspond to zones of concentrated surface runoff and are closely associated with incised channels and erosional features. The high drainage density visible in the DTM-derived network indicates efficient runoff routing, which promotes soil removal and channel deepening during intense rainfall events.

Erosion features are most pronounced along the mid- to lower-slope sections, where multiple small channels converge downslope into larger drainage paths. These areas exhibit irregular terrain textures and localized elevation lowering, consistent with active or progressive erosion. In contrast, the ridge crest exhibits comparatively lower drainage density and smoother terrain, suggesting more stable surface conditions.

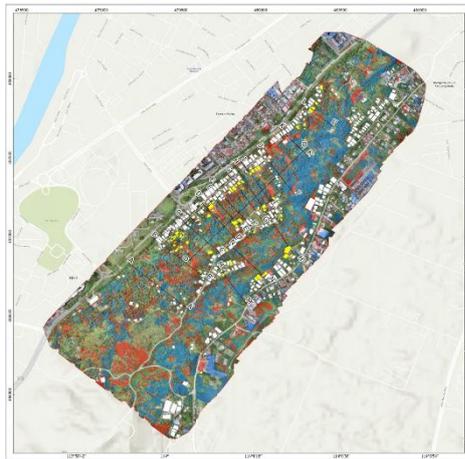
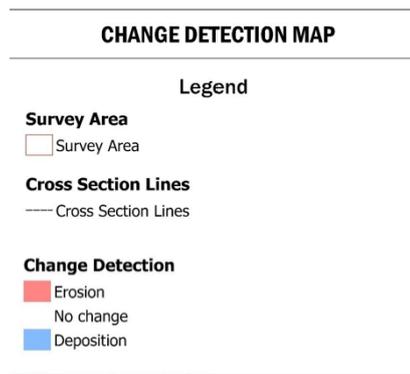
Figure 8: DTM of Difference (DoD) map showing elevation changes between the 2011 DTM and UAV LiDAR-derived DTM, highlighting erosion and deposition patterns.

Multi-temporal terrain change detection was performed by comparing the LiDAR-derived Digital Terrain Model (DTM) with a pre-existing DTM acquired in 2011. The resulting DTM of Difference (DoD) highlights spatial patterns of elevation change, enabling identification of areas affected by erosion, deposition, and relative terrain stability.

The results indicate widespread but spatially variable terrain modification across Canada Hill. Areas of elevation loss are predominantly distributed along steep hillslopes and drainage pathways, reflecting active erosion and slope degradation processes. These zones often coincide with locations where landslide-related terrain deformation was identified from DTM morphology and cross-section analysis.

Conversely, areas of elevation gain are concentrated in downslope and lower-lying sections of the study area, indicating zones of material accumulation. The juxtaposition of erosion and deposition patterns demonstrates ongoing sediment redistribution within the hill system.

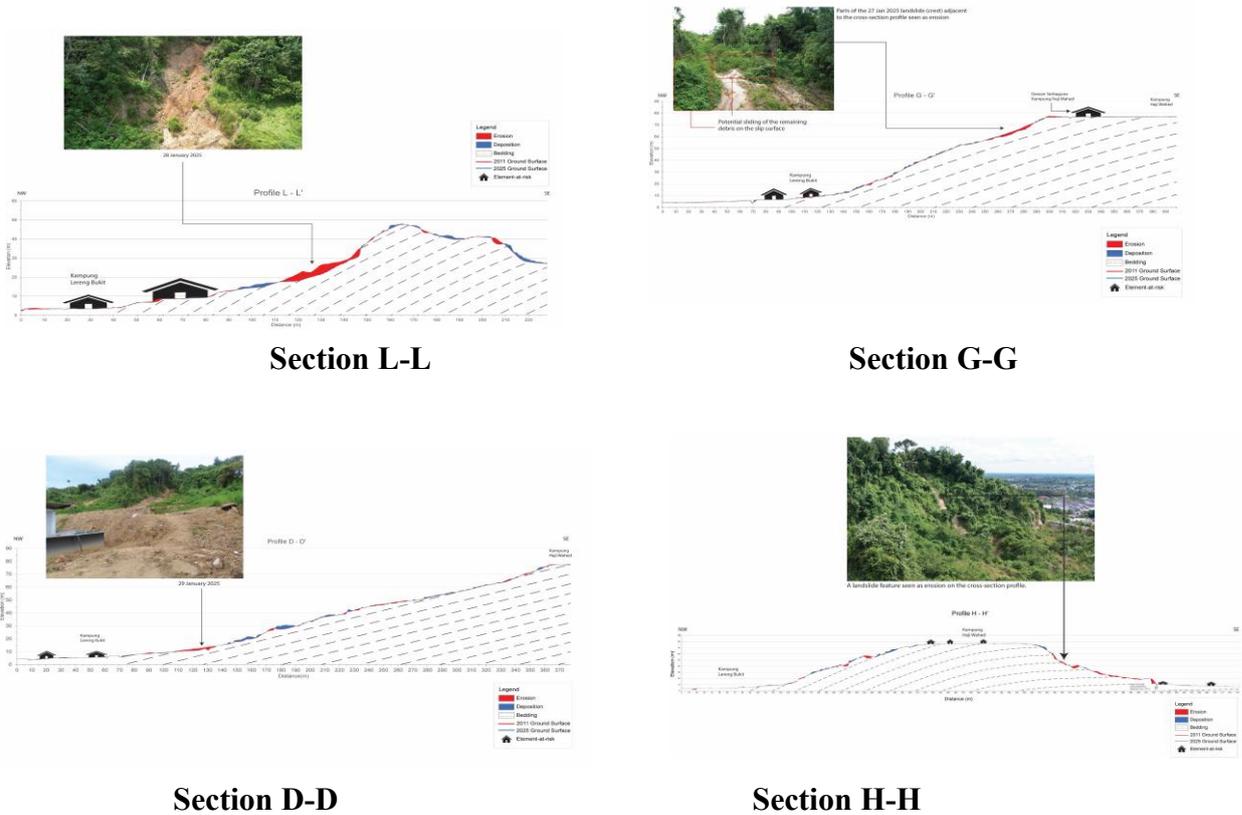
Figure 9: Representative cross-section profiles extracted from the LiDAR DTM illustrating slope deformation, erosion channels, and landslide-related terrain modification.

Topographic cross-sections extracted from the LiDAR-derived DTM provide detailed insight into slope geometry and surface deformation across selected landslide and erosion-affected areas at Canada Hill. The profiles capture elevation changes along transects that intersect identified slope instability features, enabling quantitative assessment of terrain modification that is not readily apparent in plan-view representations.

The cross-sections reveal distinct slope breaks and localized steepening associated with landslide scarps and erosion zones. In several profiles, abrupt changes in gradient are observed upslope, corresponding to head scarp locations, followed by irregular and undulating slope surfaces downslope that are characteristic of displaced or reworked material. These features indicate active or past slope movement and surface disturbance.

Comparison between terrain segments along the same profile shows clear differentiation between relatively stable sections and zones affected by erosion or landslide activity. Stable areas generally exhibit smooth, near-linear slope profiles, whereas unstable sections display concave or stepped morphologies, reflecting material removal and redistribution. In profiles intersecting erosion channels, localized incision is evident, with depressions and lowered elevations marking the position of concentrated runoff paths.

The inclusion of field photographs along selected profiles provides visual confirmation of DTM-derived interpretations. Exposed soil surfaces, shallow failures, and eroded channels observed in the field correspond spatially with zones of elevation change and slope irregularity identified in the cross-sections. This correspondence demonstrates the reliability of the LiDAR-derived DTM for capturing real ground conditions beneath vegetation cover.
