Mapping Submerged Features at Ada Estuary Using Side Scan Sonar: A Multi-Instrumental Approach to Riverbed Characterization

Key words: Side scan sonar, hydrographic surveying, underwater object detection, Ada Estuary, riverbed mapping

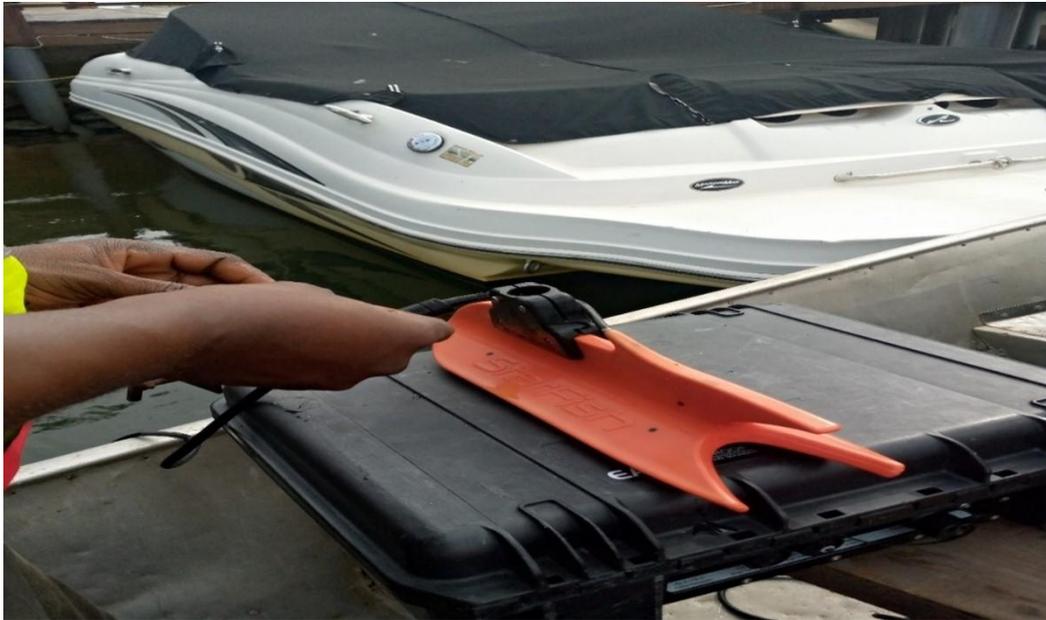
Side Scan Sonar System: A StarFish side scan sonar unit was deployed for underwater feature detection and imaging. The system operated through direct cable connection to the survey computer, enabling real-time data visualization and recording.

Figure 2: StarFish Side Scan Sonar Unit

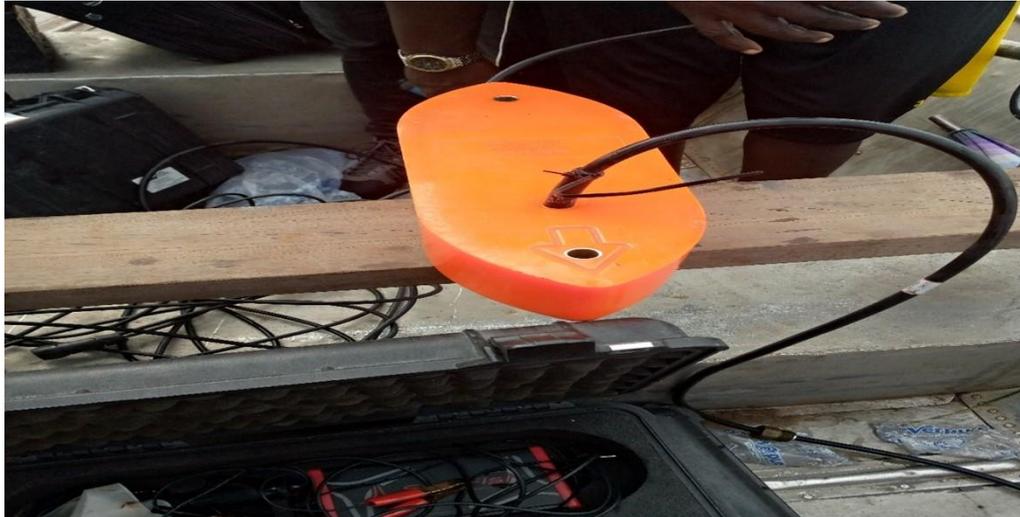
Echo Sounder: Depth measurements were obtained using a calibrated echo sounder system for bathymetric data collection. The instrument transmitted acoustic pulses to the riverbed with depth calculations based on two-way travel time measurements.

Figure 3: The Kongsberg EA440SP Dual Frequency (38/200 KHz) Single Beam Echo Sounder
