Deformation Monitoring: An Assessment of Intensity Values from Terrestrial Laser Scanner in Determining Structural Damage

Rosemond Owiredua Akuffo

FIG Congress 2026

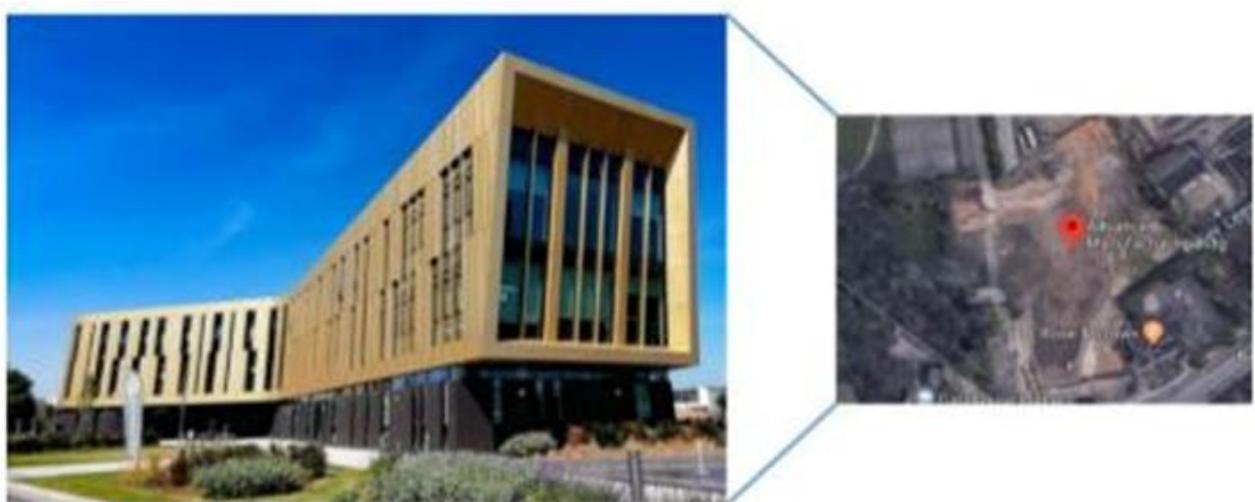
Figure 1 Advanced manufacturing building located on Jubilee Campus of University of Nottingham.

A brick wall made up of bricks and mortar was selected for this project. An existing data of the wall of Advanced manufacturing building at the University of Nottingham was chosen. Figure 1 shows the location of this building. This brick wall was considered as a structure with different surfaces thus the brick mortar was considered as a one surface while the brick itself was considered as another surface. Point cloud from a single scan was used and because this wall is new as compared to other structures on campus the scan resolution was set to 1.6mm. This resolution was chosen because not much details was needed.

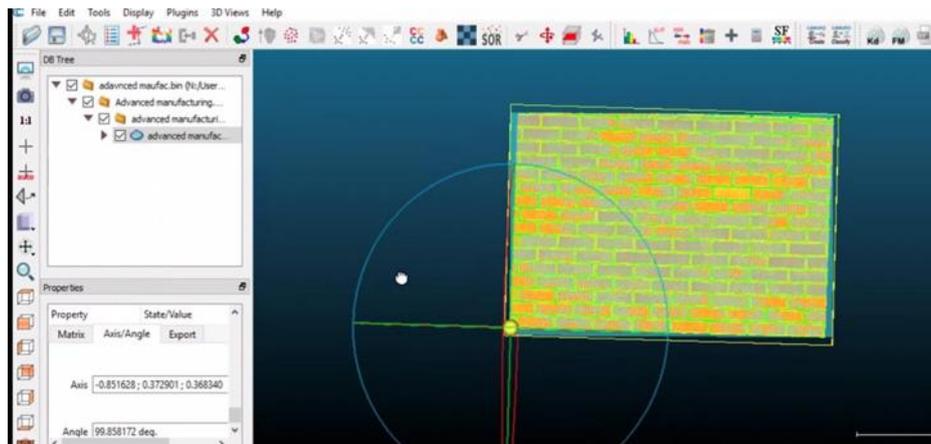
The data was imported into cloud compare and again the coordinate system was transformed such that the x axis was laid along the length of the wall and the y axis along the height of the wall leaving the z axis to define the direction of the differences that will be computed as shown in figure

Figure 2 New origin for coordinate transformation

A mesh surface (plane) was fitted on the brick mortar as seen in figure 2 because the objectives this case is to know a deep the gap between the mortar and the bricks are. Because the area left after cleaning was large which means a lot of point cloud, the software would have taken a long time to generate the mesh surface, so a small portion of the brick wall was selected. Using the Comparison map tool, the cloud to mesh (C2M) distances were generated to form a colour scale. These C2M values together with the intensity values were exported in ASCII format.

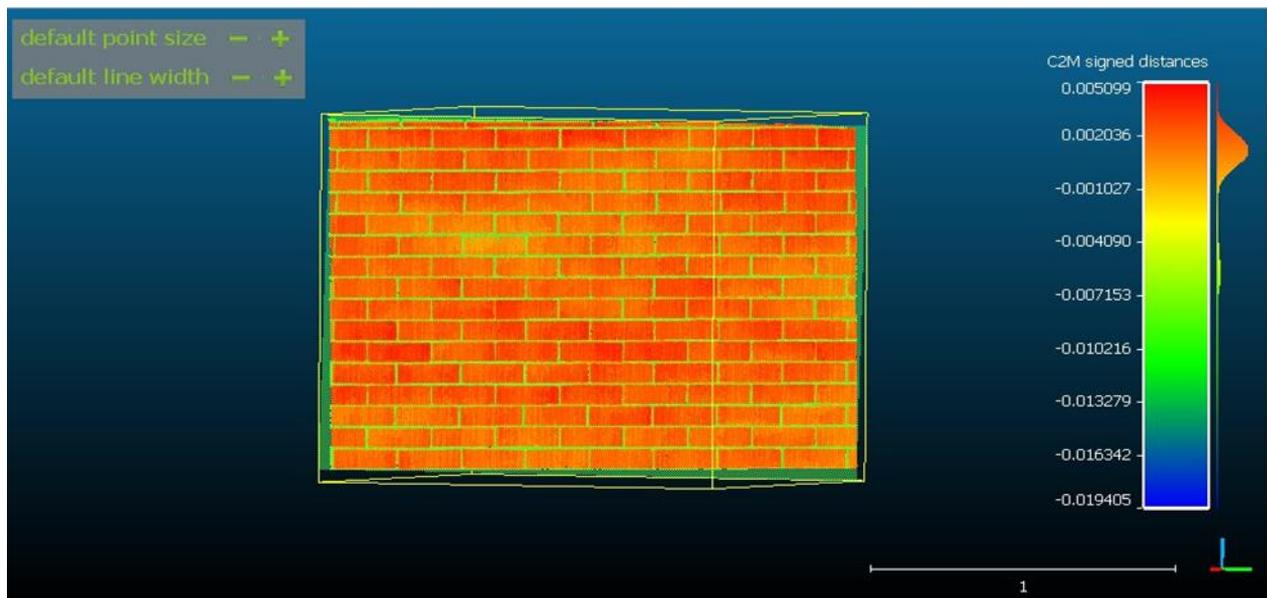
C2M distances generated were within the range of 0.0051m and 0.0194m. Majority of the small differences generated represent the brick surface in the colour red as seen in figure. These small distances are expected because as mentioned earlier the building is new as compared to the structures on the University of Nottingham campus and the plane was fitted on the brick surface. Should any different colour be seen on the brick then it would mean that there are damages like cracks on the brick which will create holes or dents on the surface of the surface of the bricks hence a bigger C2M distance.

Figure 3 C2M distances generated on the brick wall.

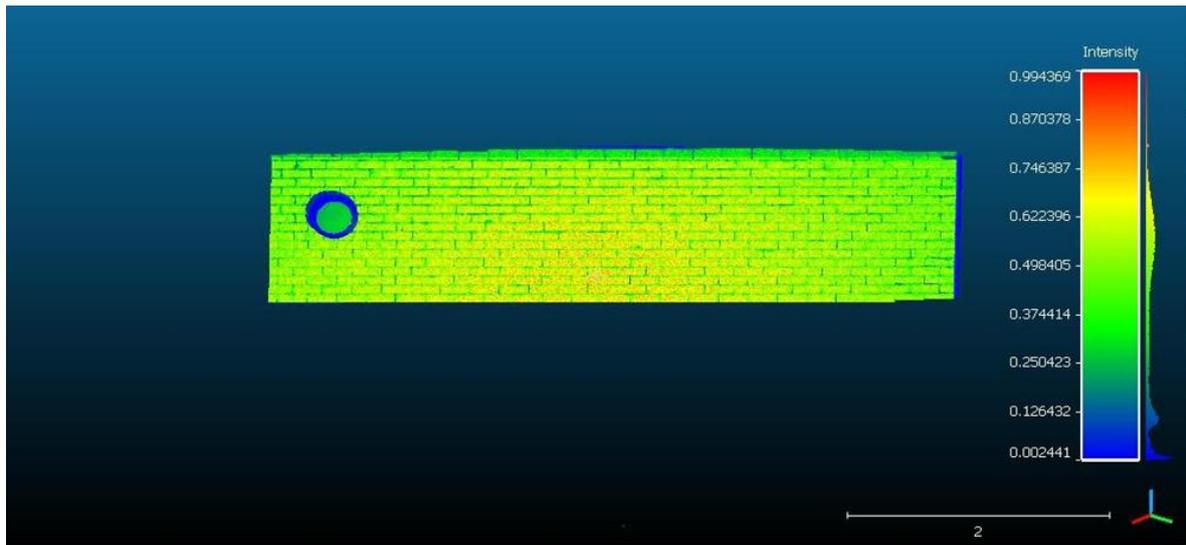
Figure 4 Display of the intensity values of the wall.

The wall was viewed according to their reflectance back into the laser scanner (intensity values). Intensity values are affected by the material of the surface it hits and by the angles and distance from the object to the laser scanner. In respect of identifying material types moisture plays a very important role in the sense that materials with a lot of moisture in them tend to absorb the laser beams hence they will have a lower intensity. From figure 4 majority of the points with moderate intensity values were seen on the bricks. These values are higher than that of the mortar surface denoted by blue colour, indicating that low intensity values. Mortar has more moisture when compared to bricks. Also, in respect to intensity values and distances from the laser scanner objects closer to the laser scanner will have a higher intensity and vice versa. This also explains the lower values from the mortar surface. The distance from the scanner to the wall is not known because data was acquired from a secondary nevertheless the mortar surface will be further away from the equipment than compared to the bricks. Again, intensity values are affected by the angle at which the laser beam hits the object. High intensities are recorded when the laser scanner is perpendicular to the object and lower intensity values are recorded the the laser beams bends at an angle. This explains why the area coloured blue in figure 35 have lower intensity values.

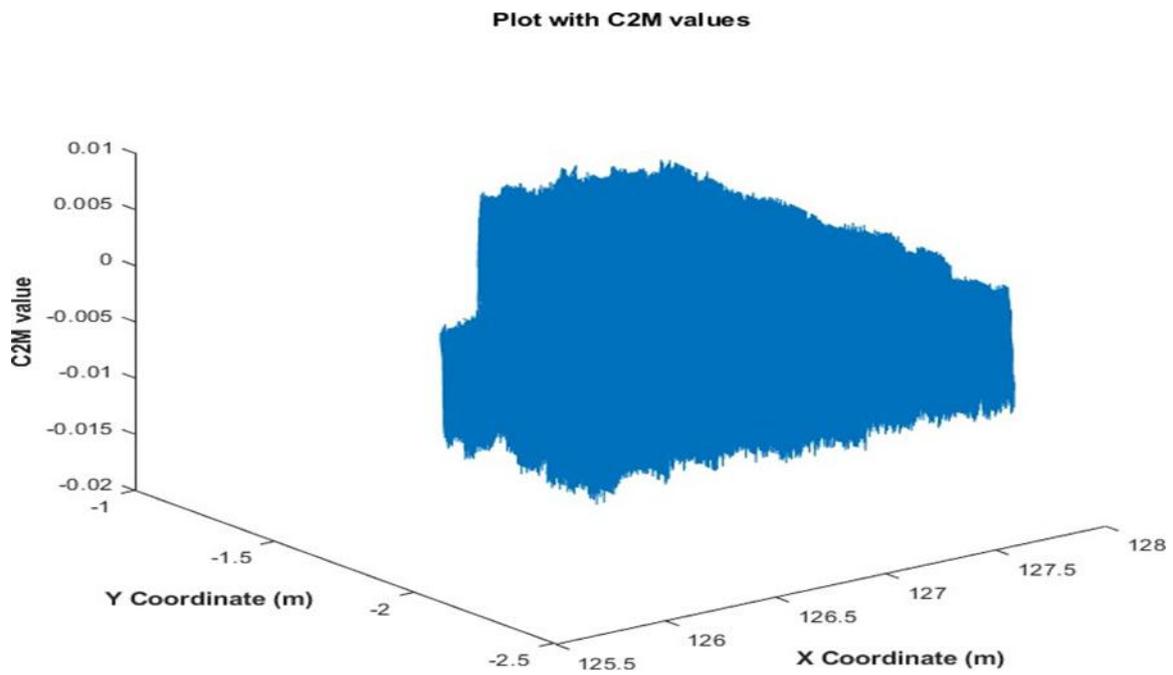
Figure 4 3-dimensional plot with C2M values

From the plots above, the highest and lowest C2M values recorded were 0.0051m and 0.0194 respectively whiles the highest and lowest intensity values are 0.994m and 0.002

Respectively. Though these two values showed the same geometry in eastings and northings, they did not fall at the exact location when the third dimension that is in the z direction was included. The intensity values were found to be larger than that of the C2M values. On a colour scale, intensity values and cloud to mesh values are correlated but in magnitude, these two values are not proportional to each other.

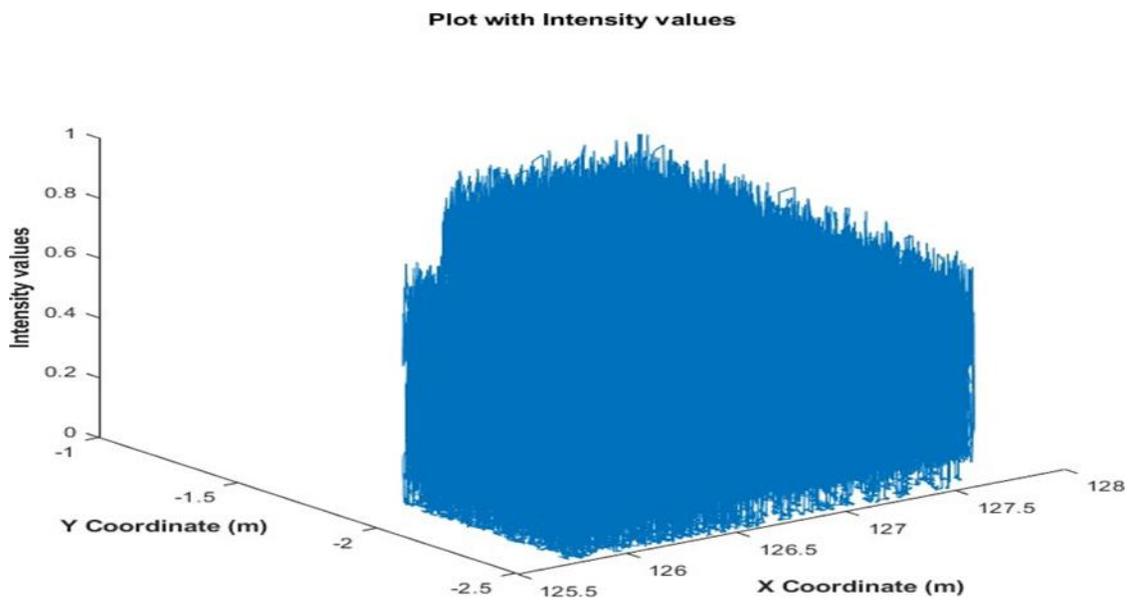
Figure 5 3-dimensional plot with intensity values

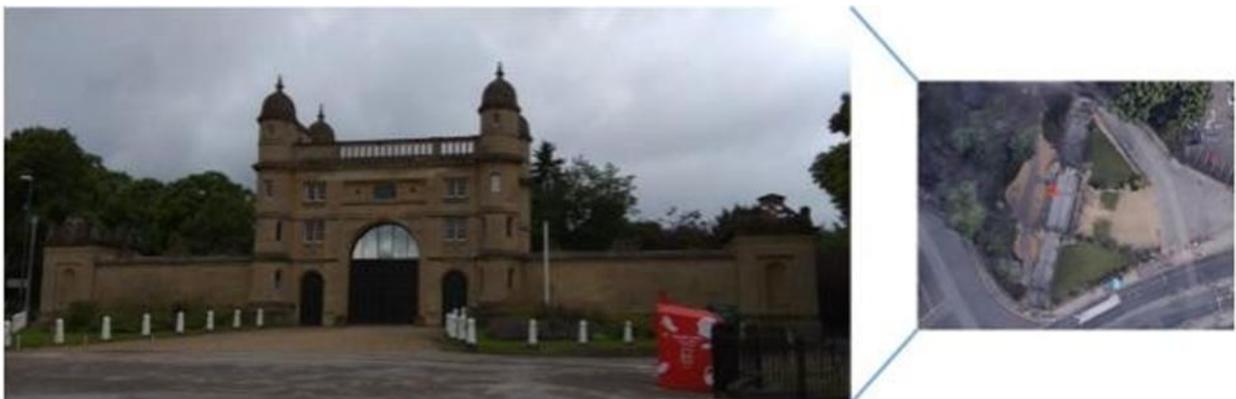
Figure 6 Old building located on the derby Road, Nottingham.

An already existing scan data from a terrestrial laser scanner of the Gatehouse Lodge façade located on the derby Road at University of Nottingham was chosen for this study. This building constructed around Wollaton park in 1825 is made up of one surface building material and because it has withstood different environmental conditions (rain, sunlight, humidity etc.) over the years certainly there will be some form of structural damages in the form of anomalies on the surface of the wall hence the need to perform structural health monitoring.

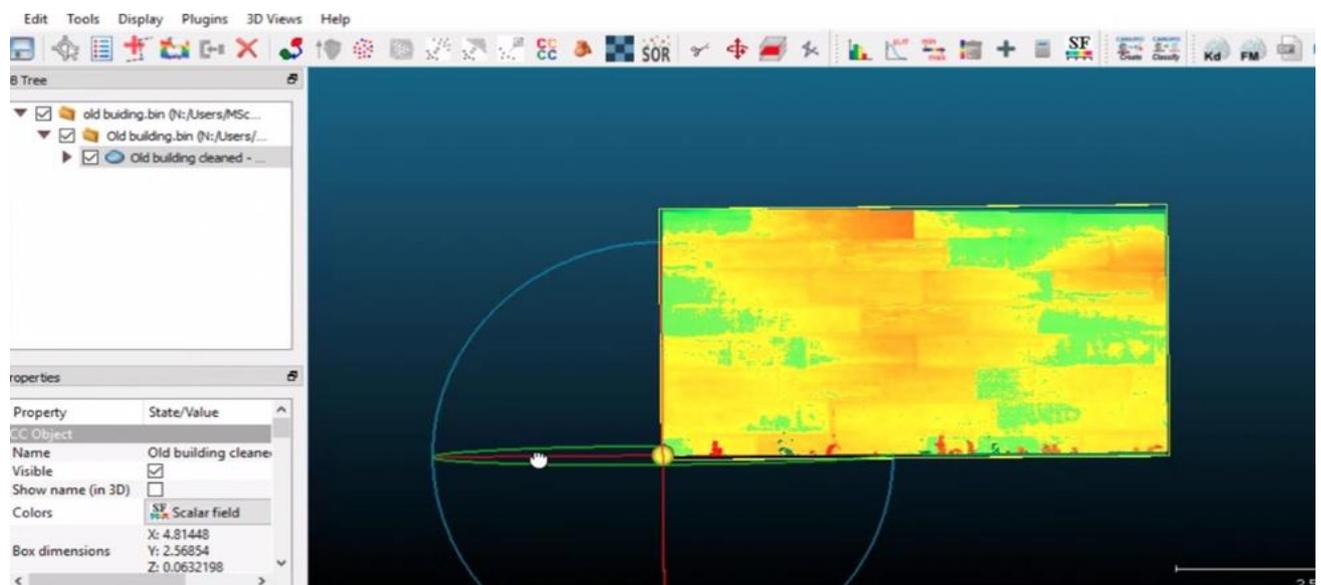
The point cloud in e57 format was imported into Cloud compare. Because this point cloud was scanned at a high resolution it took relatively longer to import all points when compared to the other data. To define the coordinate system for the wall coordinate transformation was done. The x axis was defined along the length of the wall and the y axis was made to lie along the height of the wall leaving the z axis to define the direction of the differences that will be computed as shown in figure 39 .

Figure 7 New origin for coordinate transformation

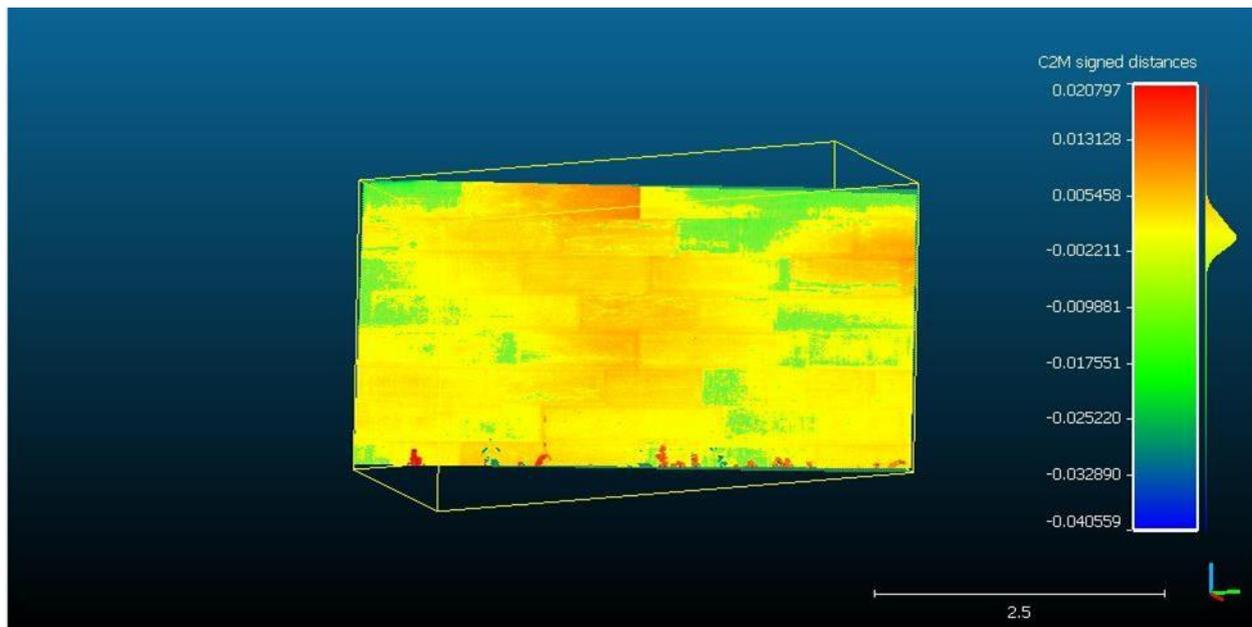
The colour scale for the C2M distances in figure 40 shows that majority of the surface area of the wall, that is the area colored in yellow, were a few millimeters (0.002m) away from the surface mesh. This could mean that these areas have little or no anomalies. However, there were bigger differences of about 0.01m to 0.02m in the areas coloured green and red. The negative values indicate protrusions on the wall because the generation of these distances were towards the positive z direction while the positive values indicates dents. To some extent the cloud to mesh distances can be used to predict anomalies on this wall.

Figure 8 C2M distances generated on the old.

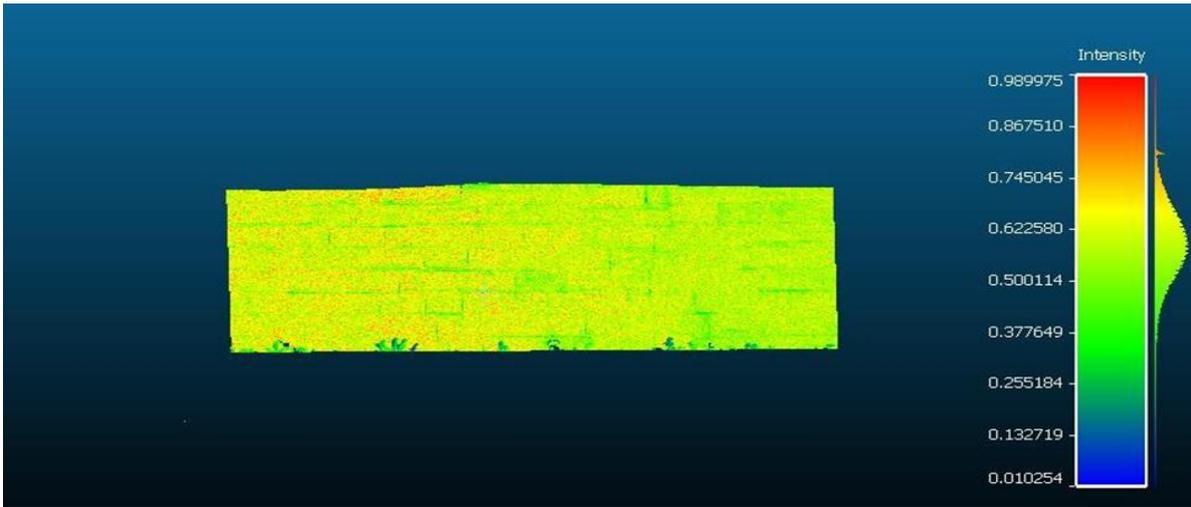
The intensity map in figure 41 on the other hand gave of a high reflectance in the areas coloured yellow however there were traces of red colour which was found at the lower part of the wall however these red areas cannot be attributed to the fact that these areas contained more moisture but rather these areas with red areas could be protrusion of the material on the wall. This wall is assumed to be flat, but it is not. There are some irregularities on the surface of the wall resulting in these parts being closer to the laser scanner as mentioned earlier object closer to the instrument tends have high intensity values.

Figure 9 Display of the intensity values of the old wall

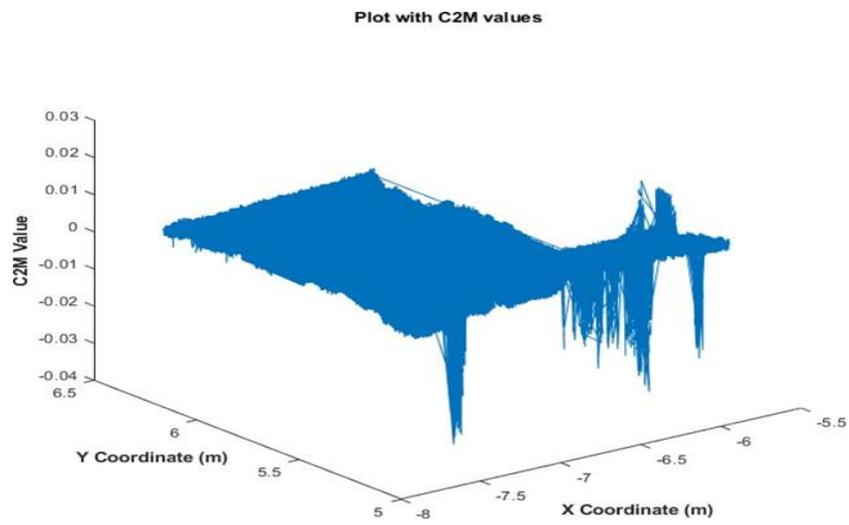
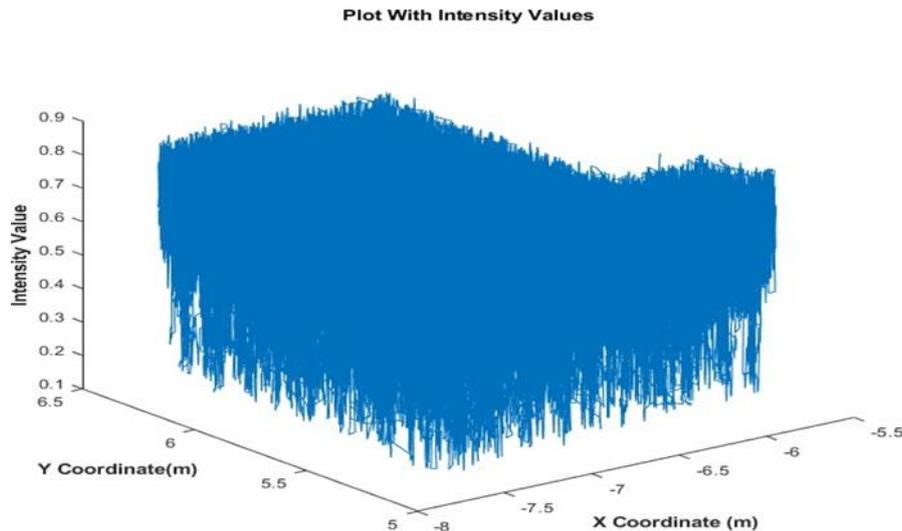
Although the C2M and intensity values showed the same geometry in eastings and northings, they did not fall at the exact location when the third dimension that is in the z direction was included. The intensity values were found to be larger than that of the C2M values. This means that there was high reflectance from the surface of the wall into the laser scanner. This could be due to the angle and distance from the wall to the laser scanner or the time of the day this data was collected.
