Bathymetric Multibeam and Aerial Lidar Survey of Wemmershoek Dam: Accuracy Assessment, Volume Analyses and Heritage Insights

James PARKES and Jonathan DINGLE, South Africa

1. SUMMARY

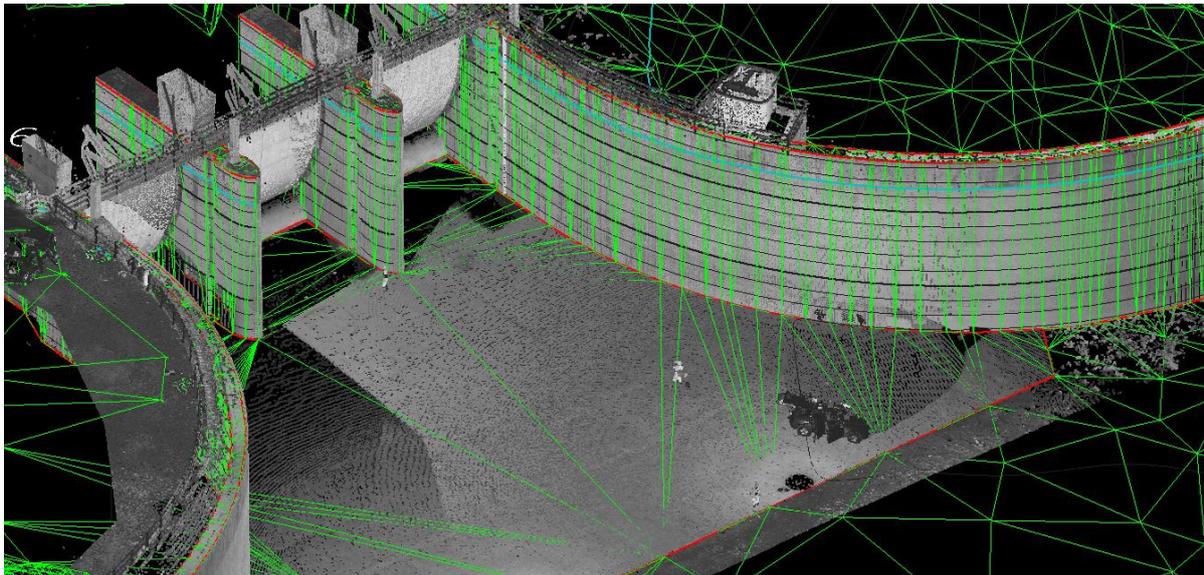
A terrestrial scan survey was conducted around the spillway infrastructure when the water level was low and the structure was exposed. Twenty-five scans were completed using the Z+F Imager 5016 laser scanner. The scans were linked to four of the GNSS control points with the largest residual being 12mm. The high-resolution scans enabled accurate modelling of the dam spillway. Critically, it also allowed for a precise determination of the spillway level, as well as confirmation of the full supply level. Figure 1 depicts the scan data of the spillway. The area includes a large, flat concrete pad, which provided a very precise comparison platform captured by all three survey technologies used on site.

Figure 1. Terrestrial Scan Data

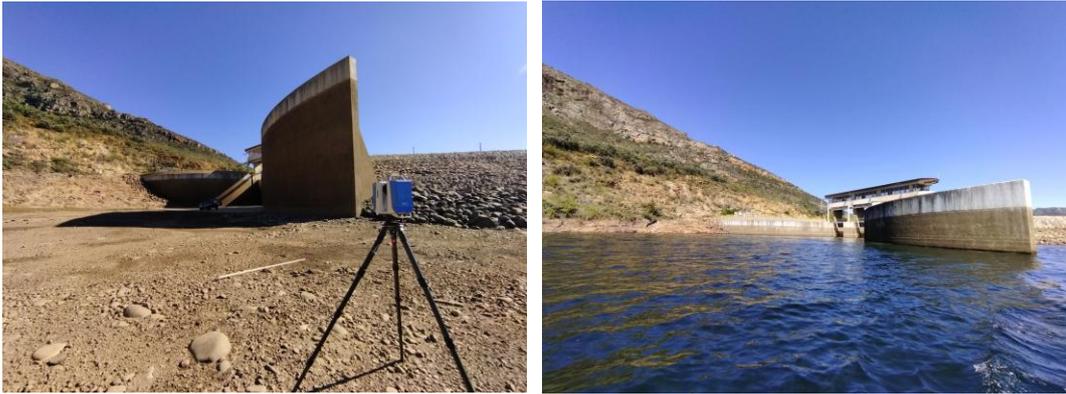
Figure 2 shows the difference in dam levels between the two site visits. The full supply level is also visible as a dark stain on the spillway wall.

Figure 2. left TLS Scan at 50% capacity; right second MBES survey at 85% capacity

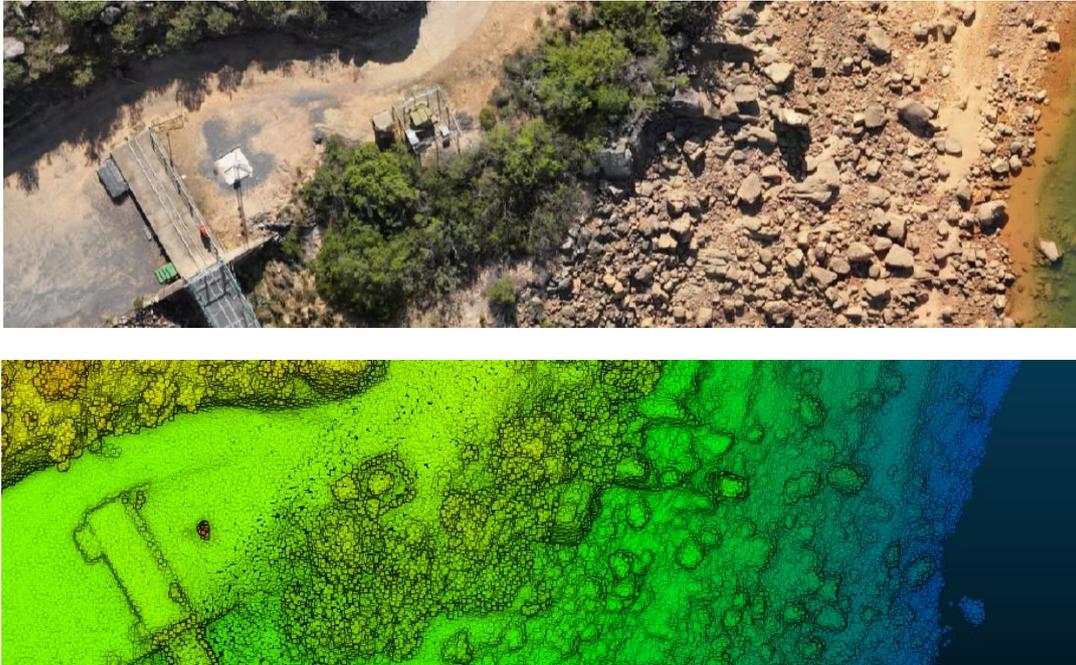
The lidar survey was conducted by a South African Civil Aviation Authority (SACAA) approved operator, capturing lidar and imagery with a DJI Zenmuse L2 lidar aboard a DJI Matic 300 drone. The service provider delivered a processed lidar point cloud and orthophoto. This data was captured at a low water level allowing for overlap with the terrestrial scan and bathymetric data, over a variety of terrains, including hard surfaces, rocky slopes, and sandy surfaces. The orthophoto and lidar were linked to the other data sets via the network of GNSS derived GCP's with vertical residuals spread over a 100mm range, which is within the expected precision for this lidar system.

Figure 3. Orthophoto and lidar data

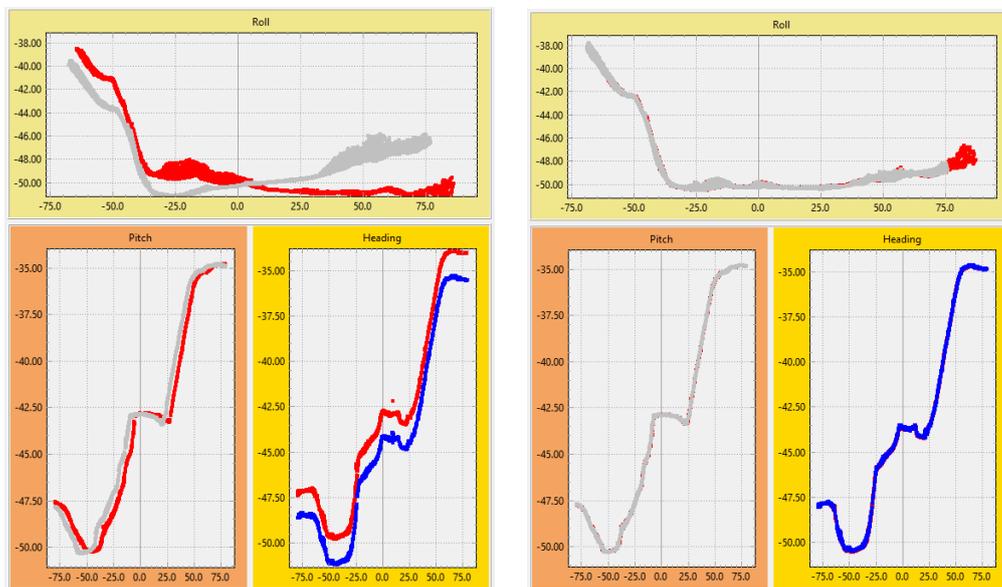
The bathymetric survey was conducted over two visits corresponding to the changes in water levels. The survey was done from the vessel “Tritan Surveyor”, a 5.5m RIB equipped with a Norbit WMBS multibeam, SBG Systems Ekinox inertial navigation system and custom made over the side pole mount for the Multibeam Echo Sounder (MBES). Sound velocity profiles were measured with a Valeport Swift SVP. A patch test was done to determine the roll pitch and yaw mounting angles of the MBES. The before and after patch calibration are depicted below.

Figure 4. MBES Calibration

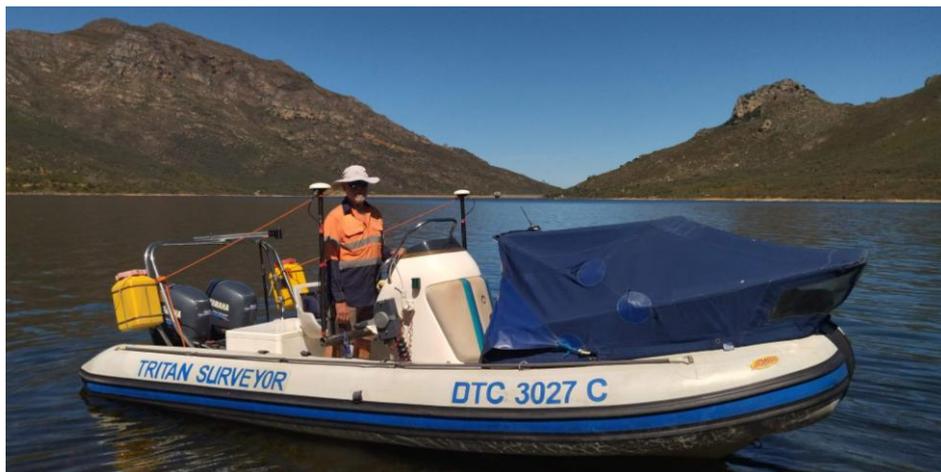
Figure 5. Tritan Surveyor

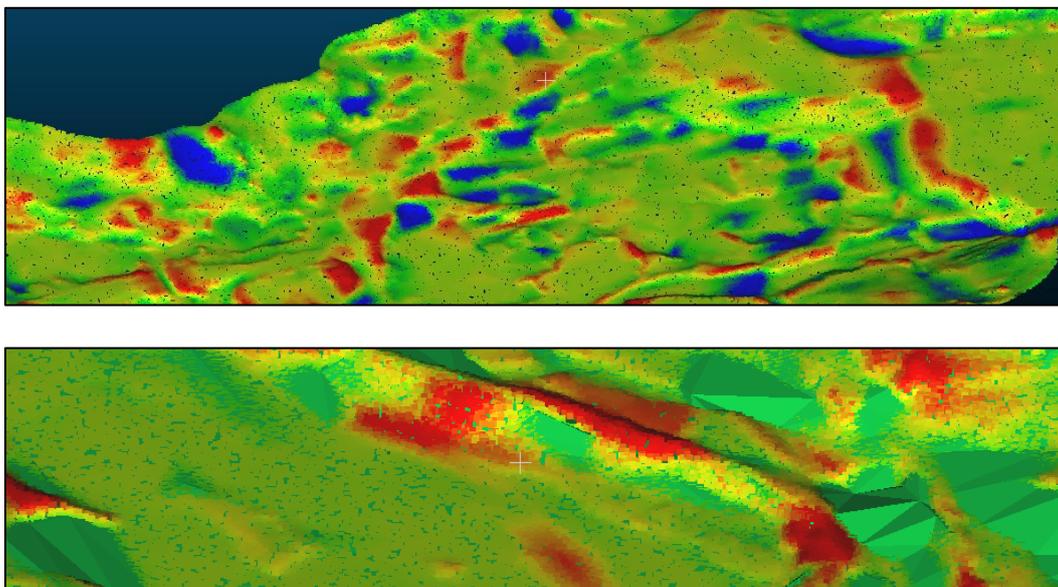
A comparison of the 2025 multibeam bathymetry data with the single beam echosounder survey (SBES) captured in 2000 demonstrates a clear improvement in resolution. By computing height differences between the two datasets, these improvements can be clearly illustrated. Figure 6 presents the resulting height differences, where red indicates berms captured by the MBES, and blue highlights gullies and depressions that were not detected by the SBES.

While a well-executed SBES survey can define the general shape of a dam, MBES data captures fine-scale detail. Berms, gullies, and break lines are clearly visible in the MBES dataset that were previously invisible. The lower image has the SBES digital terrain model visible to depict the resolution of the SBES (only the red Berms are therefore visible).

Figure 6. MBES versus SBES

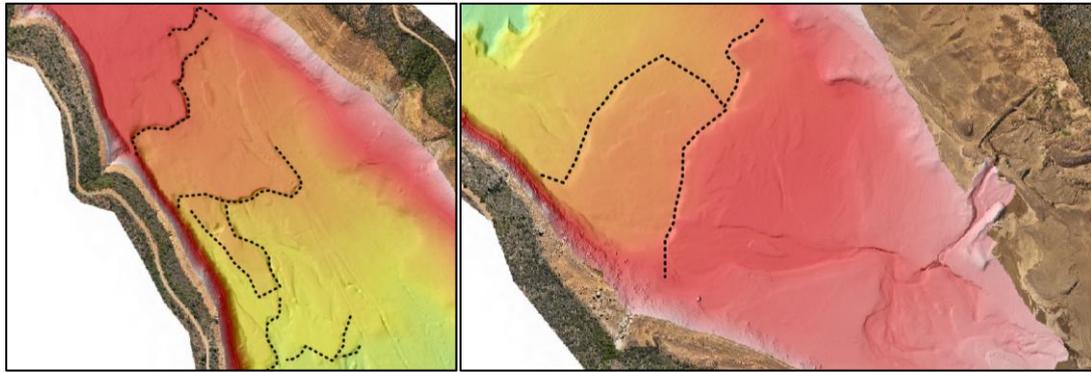
A second point of interest to demonstrate the value of having higher resolution is the ability to observe movement of sediment. Figure 7, depicts sand waves moving slowly in from the head of the two main valleys.

Figure 7. Leading edge of waves of sediment ingress at the head of the two main valleys.

Little sedimentation is observed along road alignments and previously worked areas. Areas where streams are visible suggest that these features have experienced minimal sedimentation since their formation during open-air construction. Based on the sedimentation evident at the heads of the inflowing rivers, it can be concluded that most of the sediment deposition over the past 70 years has occurred in these upstream areas. The catchment does lie in the upper reaches of the river system. It is therefore conceivable that the large-scale sedimentation commonly observed in other dams is likely avoided.

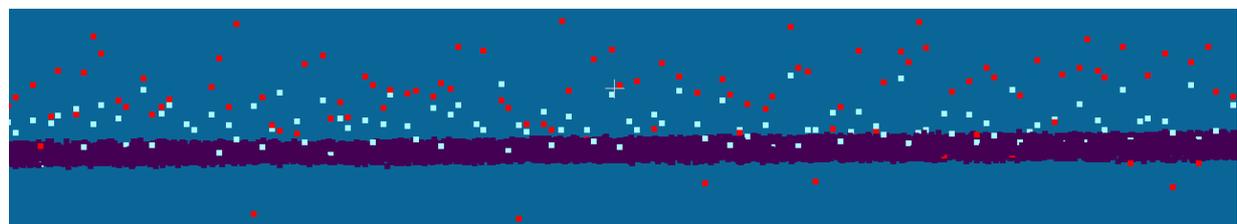
As previously mentioned, the opportunity to compare these three technologies is not frequent. This comparison is especially unique, as the spillway consists of a large, flat concrete pad, allowing for a clean comparison without additional compounding factors. The distances between the terrestrial data and both the MBES and lidar were computed. A histogram of these distances was derived. The results of this are recorded in Table 1, where noise is represented by the standard deviation of the differences and accuracy by the mean of the differences. The accuracy assessment is indicative rather than rigorous as the test is conducted over a single area, and results may vary elsewhere.

*Lidar is shown in red, terrestrial scan in purple, and MBES in blue.

Figure 8. Cross Section Concrete Pad

Data Acquisition	Noise	Accuracy
Lidar (0.25 Grid)	29mm	41mm
MBES (0.25 Grid)	13mm	8mm
Terrestrial Scan (unfiltered)	<5mm	Reference
* Accuracy measured against the terrestrial scan data		
* Noise measured as Std dev

The MBES is comparable to the terrestrial scan data in this instance. Although favourable conditions, shallow depths, and the slow speed of the bathymetric survey made this possible, it is nonetheless impressive to see how far sonar technology has progressed in terms of resolution and precision.

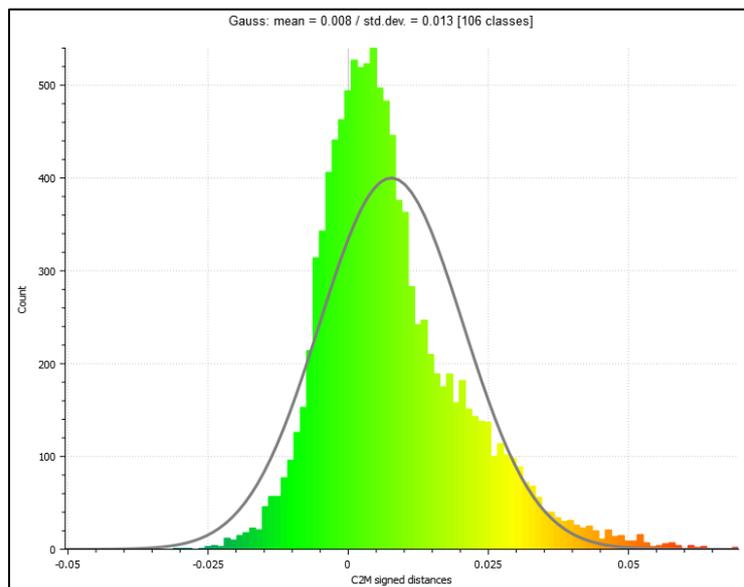
The final datasets were overlaid, with both the lidar and MBES data gridded at 0.25 m and compared against the terrestrial data. The terrestrial data acting as the baseline was gridded to 0.1m and triangulated enabling distances from it to be calculated. The gridding enables a more direct and consistent comparison.

Figure 9. MBES distances to terrestrial scan

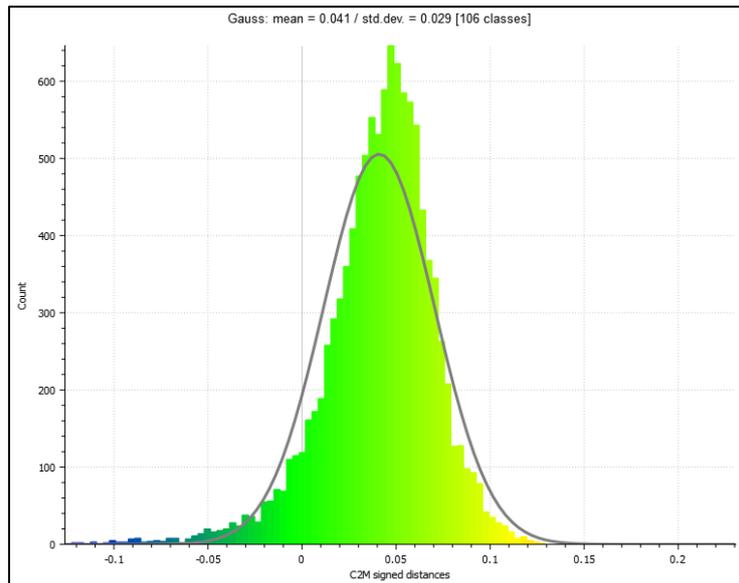
Figure 10. Lidar distances to terrestrial scan

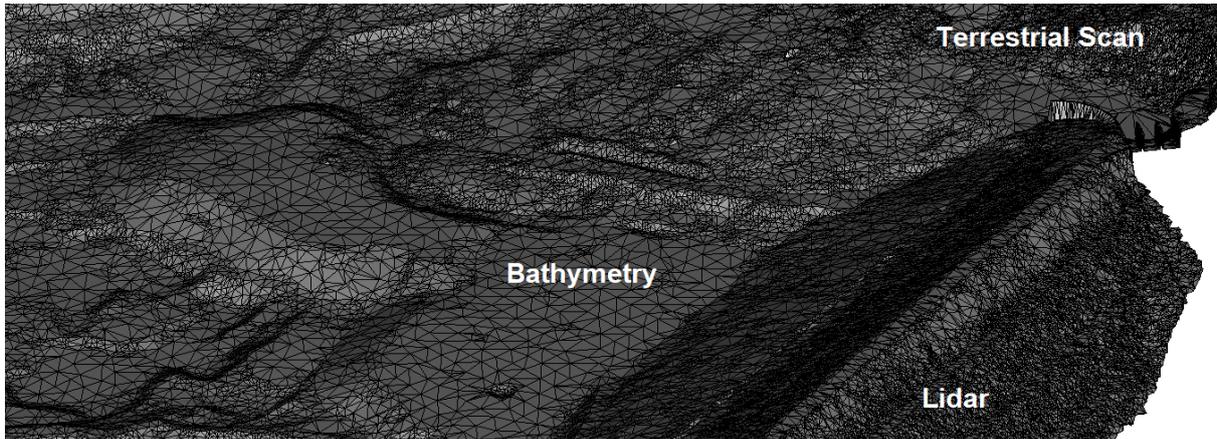
Up to date technology as well as careful processing will result in a high-quality calculation. The method involves creating a triangulated digital terrain model (DTM) of the dam area and then calculating 10mm volumetric slices through its entire height. The combination of mapping techniques in the appropriate areas can yield a high-fidelity model. Depicted in Figure 11 is the combined model.

Figure 11. Triangulated DTM model.

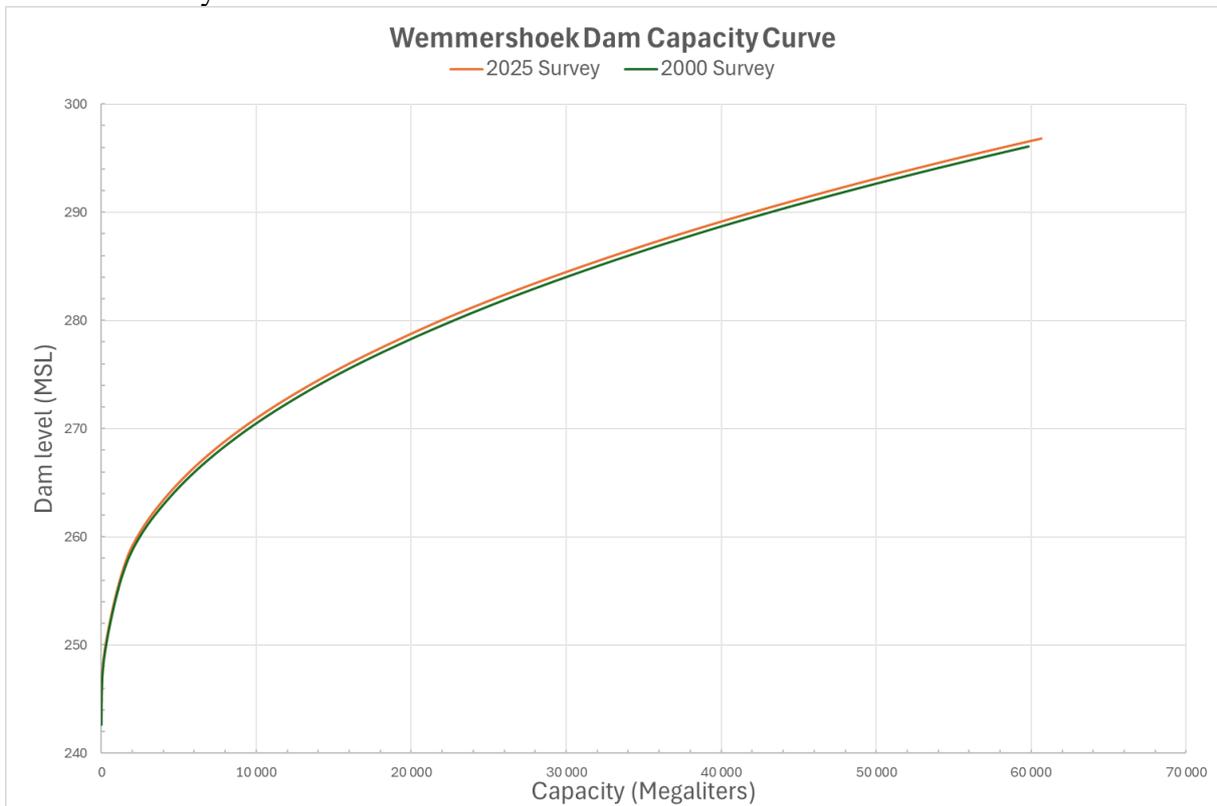
The capacity calculation derived from the MBES survey is shown in Figure 12 alongside a single-beam calculation completed in 2000. The graph indicates a slight decrease in capacity, which may be attributed to improved data resolution or sedimentation. However, the capacity curves are remarkably similar. This suggests that a carefully conducted single beam survey, although of lower in resolution, can still produce capacity curve data that is comparable in overall accuracy to that derived from the MBES data.

Figure 12. Capacity curves.

In summary of this section, a well-conducted MBES survey results in substantial improvements in resolution, result confidence and point accuracy. However, if similar due diligence is applied to a lower resolution survey such as one derived from SBES, similar results can be achieved.

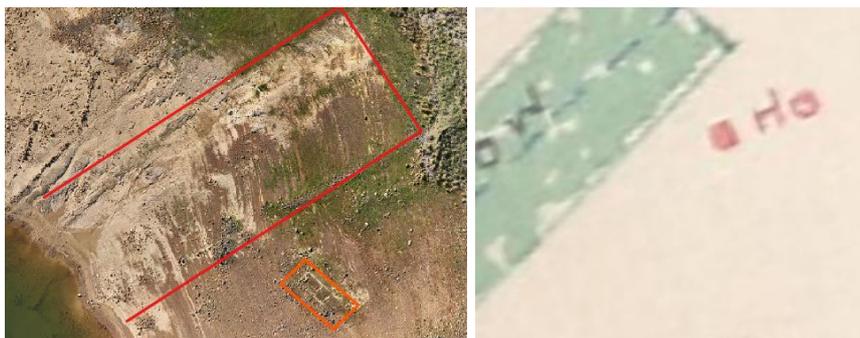
Figure 13 depicts the remains of the long field and house visible in both the diagrams. The 1896 diagram for this area indicates it was “Garden Ground Free Hold”. Once pointed out the feature is obvious, though it demonstrates how hidden a historical object can be.

Figure 13. Garden Ground Free Hold (Pritchard, 1901)

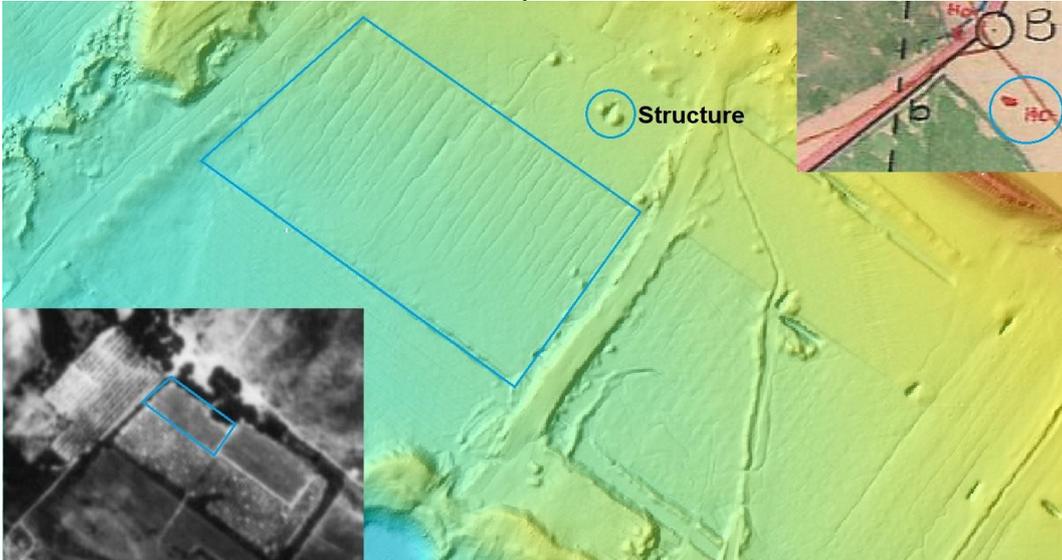
When this imagery is compared with the MBES data, it becomes possible to observe how such large-scale features can be expected to appear in high-quality multibeam datasets. In addition, smaller individual planting furrows and drainage features are clearly visible, at a level of detail comparable to that seen in mid-20th-century aerial imagery. This is illustrated in Figure 14.

Furthermore, the position of the homestead can be inferred from the 1903 diagram, and this is supported by the historic photography showing that the area is heavily wooded and adjacent to a road. It is therefore highly likely that this location corresponds to the homestead. We can speculate from this what a ruined structure may look like in MBES data.

Figure 14. Historic Farms *Aerial image (Chief Directorate: National Geo-spatial Information, 1949)

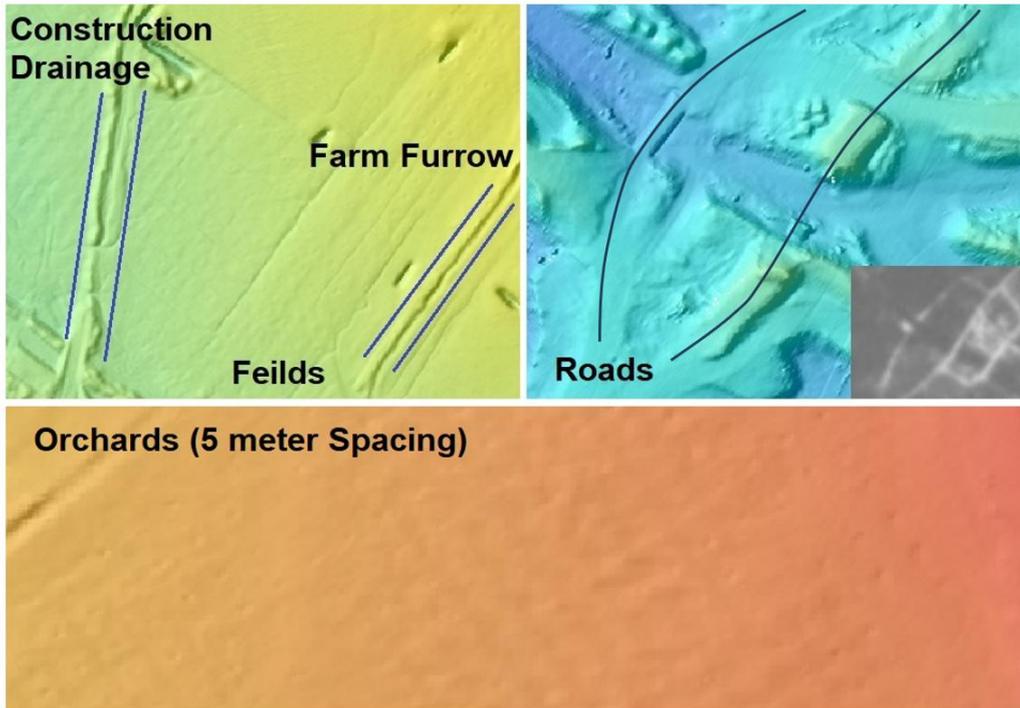
The MBES data itself is the most revealing in terms of the historic landscape. In undisturbed areas, the farm field layouts and irrigation networks are clearly visible. In some cases, the resolution is of sufficient detail to distinguish orchard from farm field. It is truly remarkable that sonar derived imagery has advanced to point at which it can be captured in higher resolution than that of Aerial photograph of the 50's.

Figure 15. Farm and road detail.

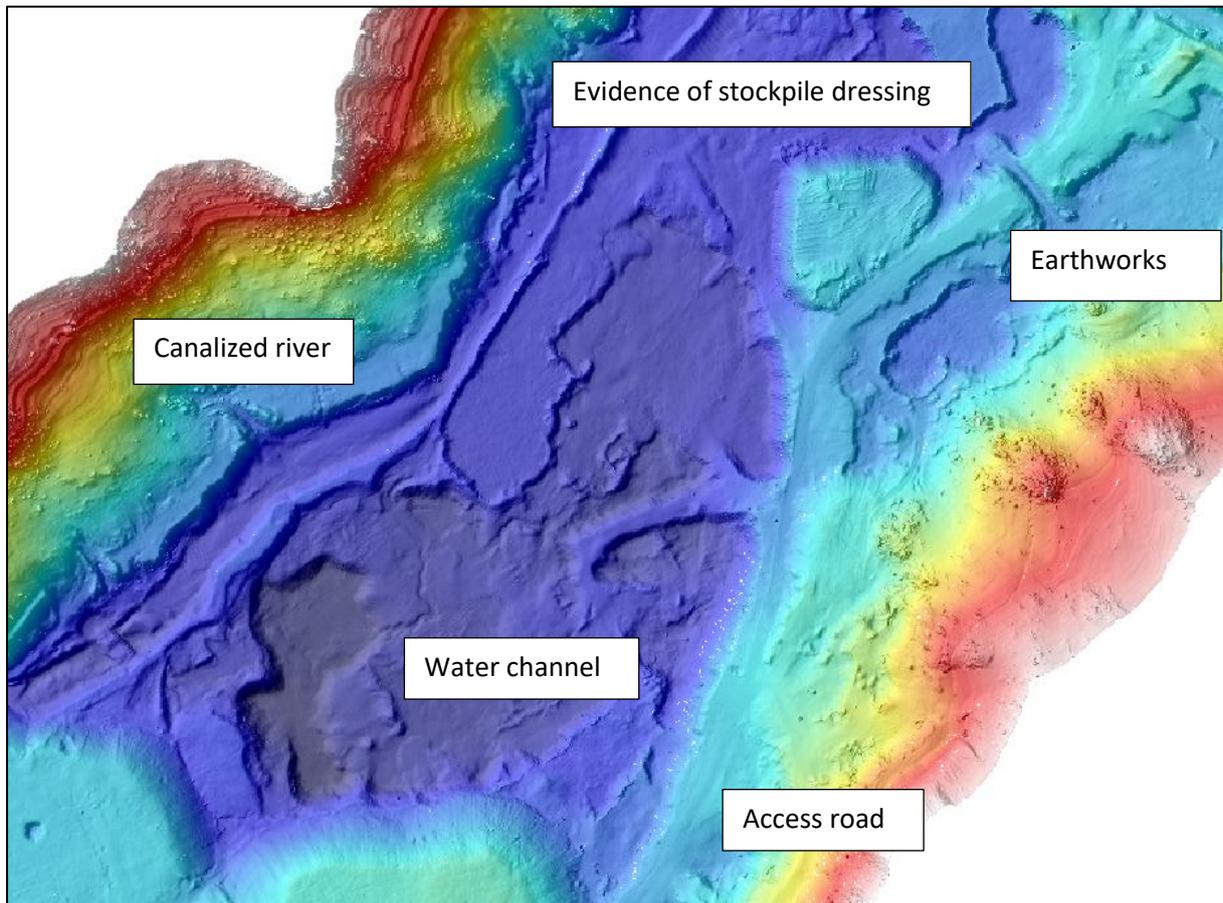
Other areas of the dam clearly highlight the substantial earthworks undertaken during construction of the dam wall. As depicted in Figure 16, earthworks, stockpiles and water channels are evident.

Figure 16. MBES extract of dam Earthworks.

Insite can be gleaned into the sedimentation processes in the area, because of the high resolution of the modern data set and the temporal range of the surveys. As an example of this we can observe in Figure 16, the massive earthworks from the dam’s construction. Where stockpiles remain above the current dam bed, it can be inferred that no significant sedimentation has occurred. Similarly, areas showing evidence of vehicle movement suggest an absence of sediment accumulation.

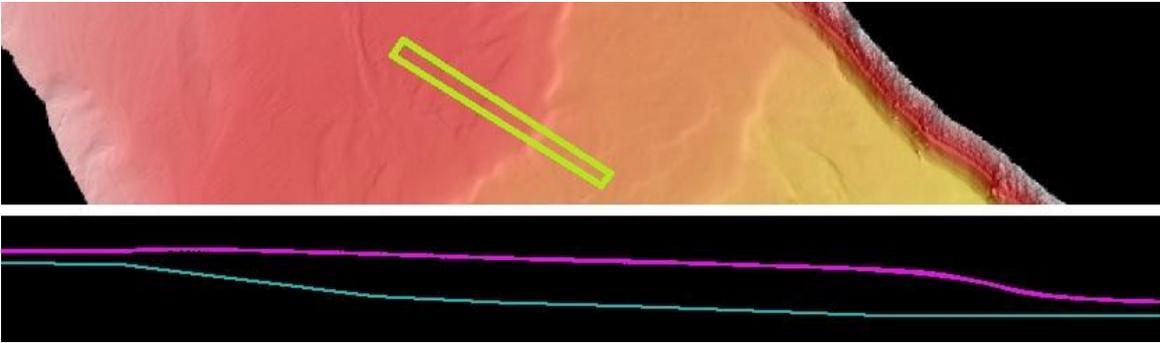
The sand wave at the head of the inflowing river to the north can be observed in the 2000 SBES survey. It is visible only because, during the SBES survey, a single survey line was run directly over the sand wave. Figure 17 depicts a cross-section through the sand wave, comparing the 2025 survey (purple) with the 2000 survey (blue). In this instance, the sand wave has migrated approximately 40 metres downstream.

Figure 17. Sand wave SBES versus MBES

The limitation of SBES data is that it captures only isolated instances of sediment movement, often coincidentally, rather than providing the complete spatial picture achievable with MBES data.
