Integrating Laser Scanning, BIM, and Virtual Reality (VR) Technologies for Monitoring and Restoration of Existing Historical Structures

**Hanniel Tetteh DJABA, Ghana
Krzysztof KARSZNIA, Poland**

Keywords: laser scanning; BIM; gaming technologies, structural monitoring

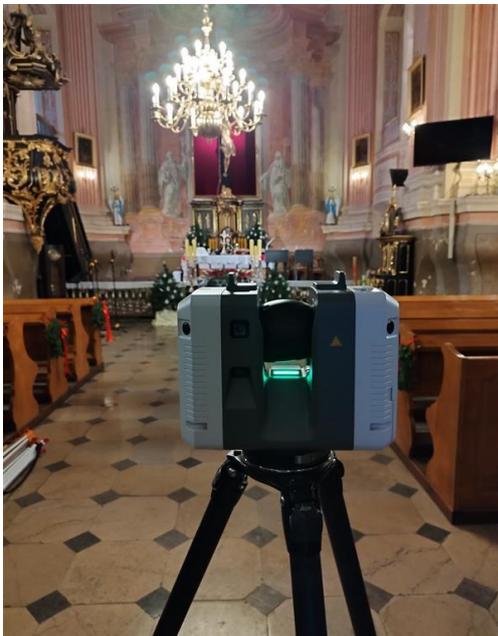
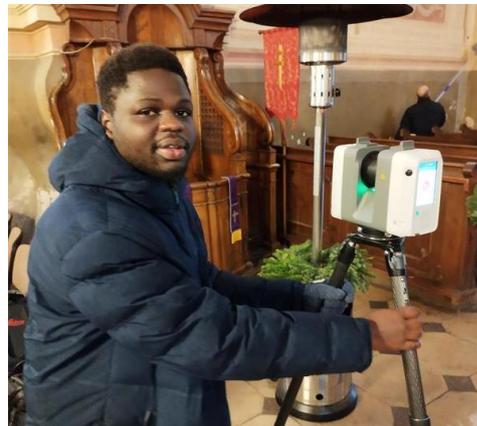
Fig. 1 Lector RTC 360 Scanner at the abbey to Capture Point Clouds

- **Data Acquisition:** high-resolution 3D scans were obtained using the Leica RTC360 scanner as shown in Fig. 1.
- **Data Processing:** point cloud data were cleaned, registered, and optimized for structural analysis.
- **BIM Model Development:** the structured data was used to create a digital representation of the Abbey.
- **Immersive Visualization:** the finalized BIM model was visualized using gaming technologies.

The Leica RTC360 terrestrial laser scanner was used for data acquisition, providing high-precision 3D point clouds of the Benedictine Abbey (Fig. 1). The abbey has dimensions of length 27 meters, a width of 9 meters, and a height of 20 meters. The scanner was positioned at multiple locations within the abbey to ensure full coverage of the interior of the structure, including architectural details, floor levels, and observable structural deformations.

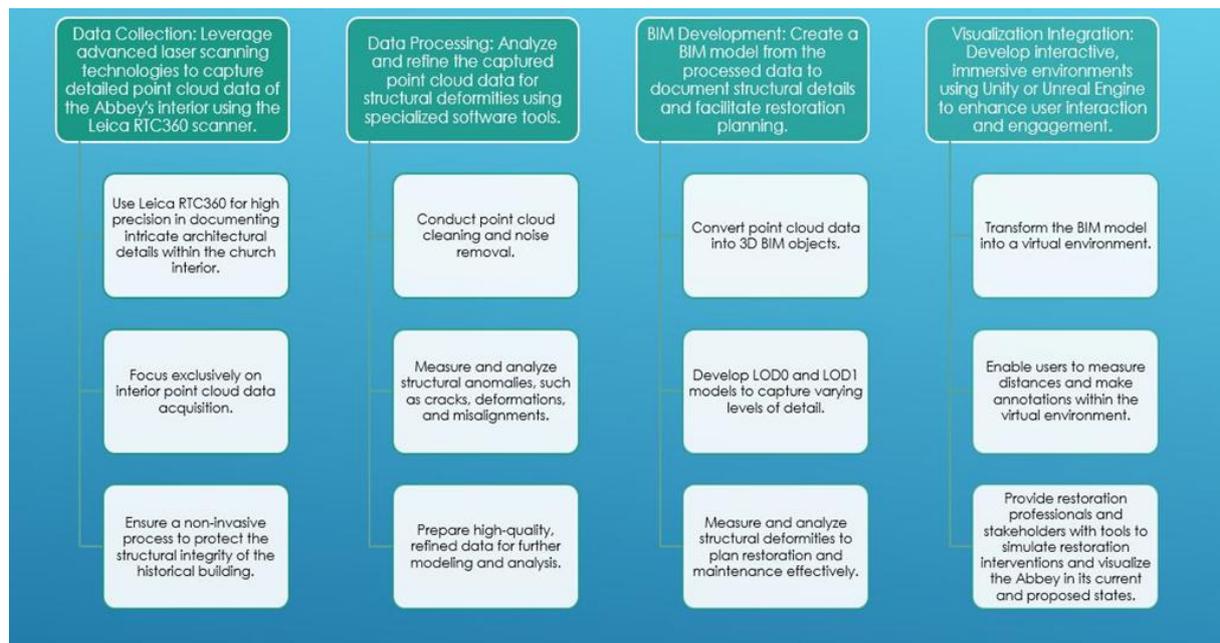
Fig. 2 Block chart for the modelling workflow phases (own elaboration)

A block diagram representing the research workflow is illustrated below:

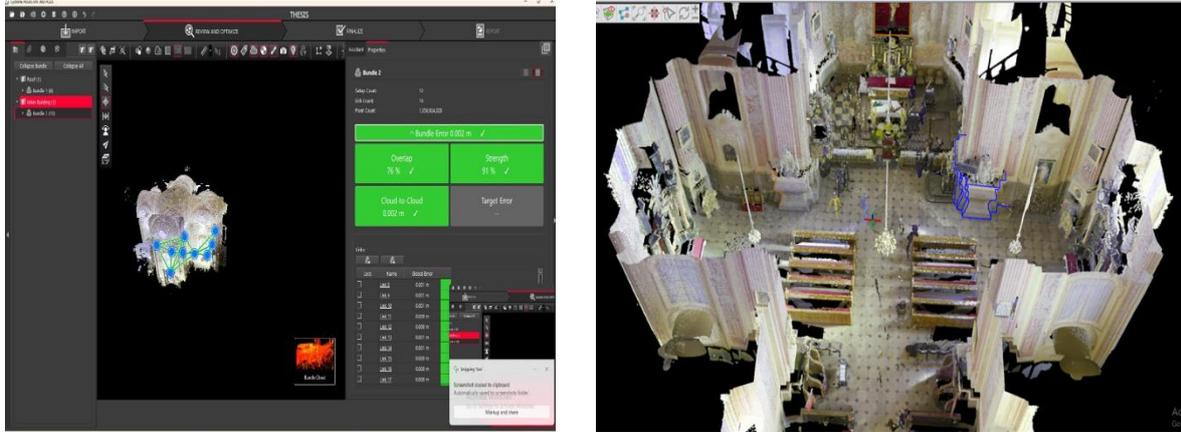
Fig. 3 The results of point cloud processing based on the abbey laser scanning (own elaboration)

As mentioned, the processed point cloud is presented in Fig. 3, illustrating the high-resolution spatial dataset acquired from the Abbey. This dataset, generated through TLS surveying, provides a geometrically accurate basis for subsequent analyses, including deformation studies, material degradation assessment, and the development of BIM-compatible geometric models.

The Leica RTC360 scanner successfully captured high-resolution point clouds, documenting the Abbey's existing condition. The final dataset was refined through multiple filtering steps, yielding a registration accuracy of 0.002 meters and an overlap rate of 76%, ensuring highly reliable data as shown in Fig 3.

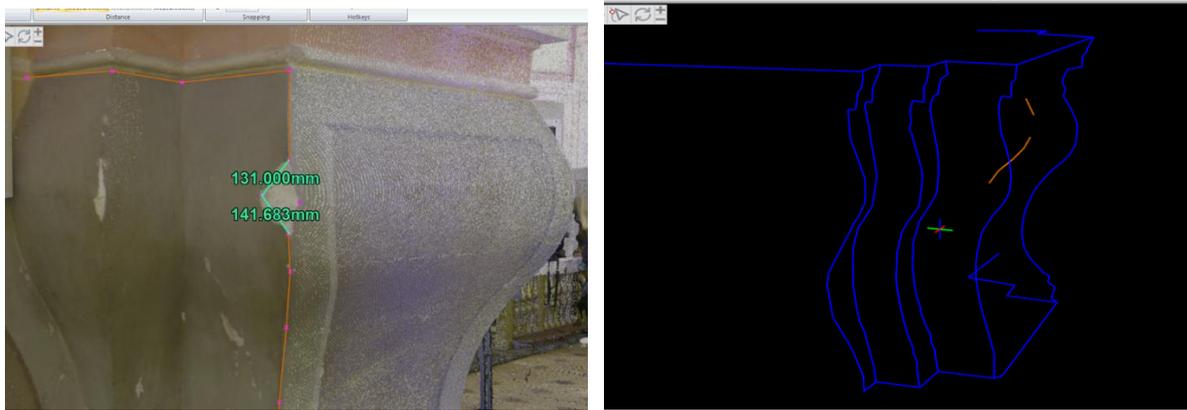
Figure 4, in turn, shows the results of the damage and material-loss measurements performed on the historic masonry walls using the derived modelling products. The integration of the classified point cloud with mesh-based surface models enabled precise quantification of surface detachments, erosion patterns, and structural discontinuities. These outputs supported the creation of thematic maps and diagnostic layers, which are essential for conservation planning, structural evaluation, and long-term monitoring of the monument's condition.

Fig. 4 Crack Measurements and BIM Model of two Separate Walls in the Abbey (own elaboration)

- LOD0 and LOD1 BIM Models: the LOD0 model provided a simplified floor plan, while LOD1 included detailed representations of walls, structural elements, and deformations.
- Integration of Structural Monitoring Data: identified cracks and material deterioration were incorporated into the BIM model for restoration planning, as shown in Fig. 4.

As illustrated in Fig. 4, cracks were clearly identified and measured, revealing deformations of up to 141.7 mm in critical wall sections. These values reflect long-term dimensional shifts within the masonry and indicate potential structural weaknesses that may compromise the building's stability. The ability to precisely locate and quantify such deformations provided essential input for subsequent BIM generation and structural assessment.

- Crack Analysis: measurements revealed deformations up to 141.7 mm in critical wall sections as shown in Fig. 4.
- Surface Irregularities: the point cloud clearly depicted material degradation, enabling targeted restoration efforts.

The LOD1 BIM model was developed to incorporate key structural defects—such as wall cracking patterns, geometric deformations, and weakened ceiling struts—as already illustrated in Fig. 4. By embedding these deterioration features directly into the BIM environment, the model served not only as a geometric reference but also as a diagnostic layer supporting structural health monitoring workflows.

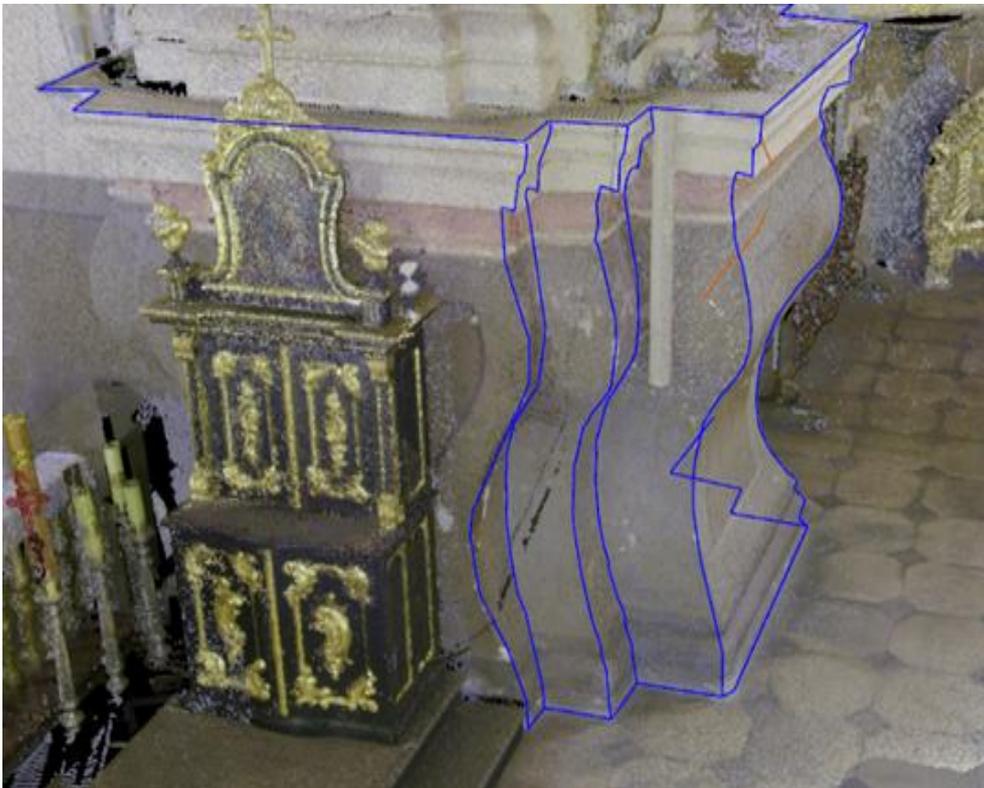
Fig. 5 An example of how a point cloud-based BIM modelling is generated (own elaboration)

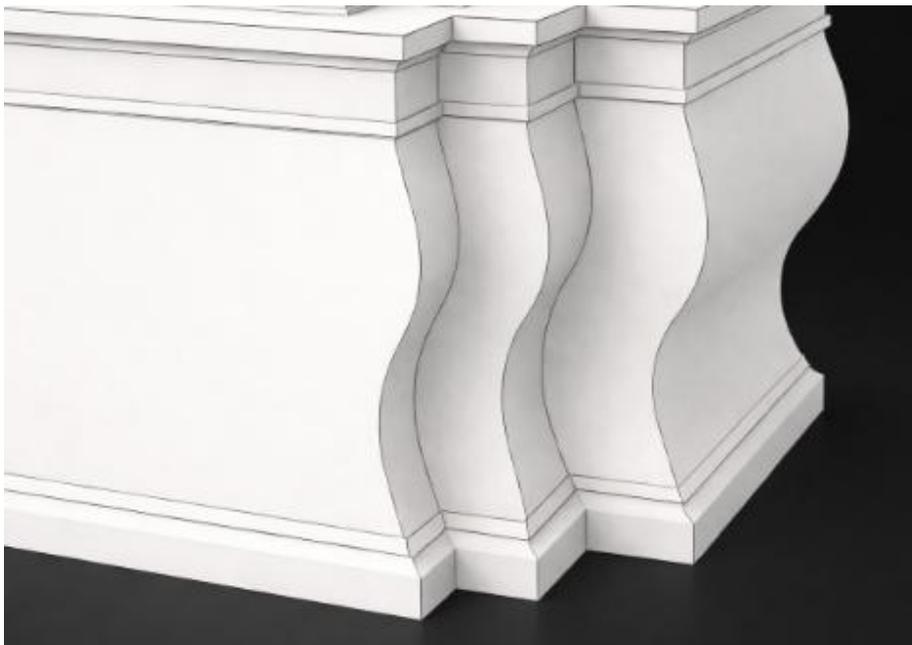
Fig. 6 An example of the final point cloud-based BIM model (own elaboration)

Furthermore, the BIM model functioned as a comprehensive restoration and monitoring framework (Fig. 6), consolidating spatial data, historical documentation, and engineering assessments into a unified digital environment. This data-driven approach enhanced decision-making for conservation teams by enabling scenario testing, prioritization of interventions, and long-term planning based on quantifiable structural performance indicators.

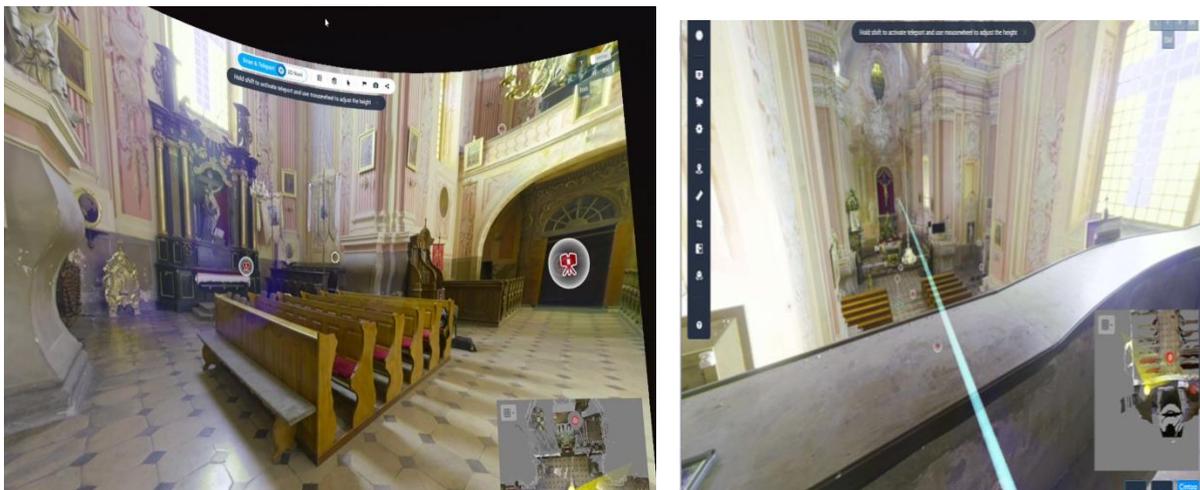
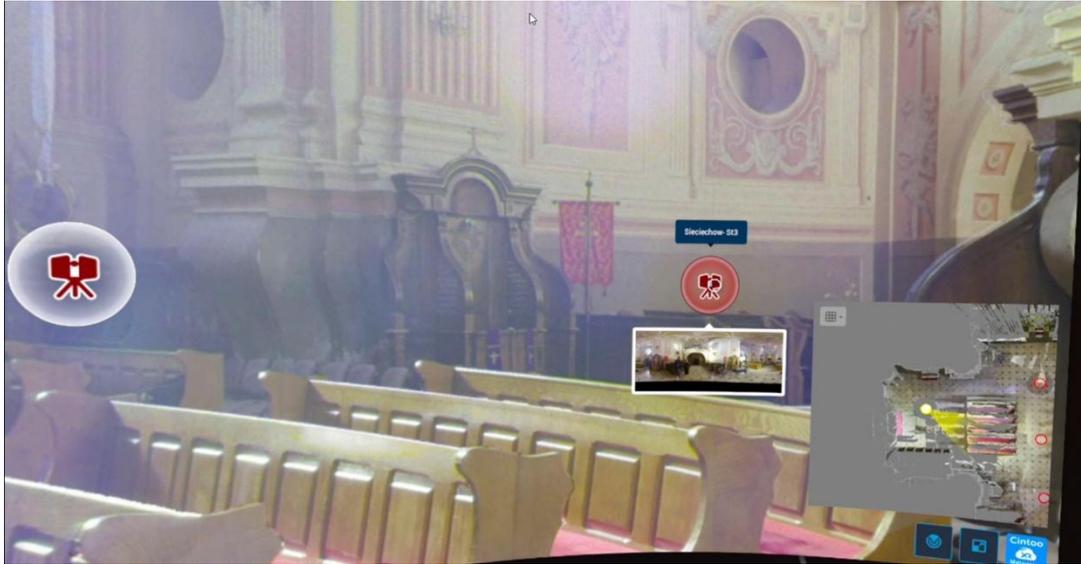
Fig 7. Point Cloud Visualization in Unreal Engine- Cintoo (own elaboration)

To enable interactive exploration and detailed analysis, the BIM model of the Abbey was imported into Unreal Engine (accessed on 03.07.2025) for immersive visualization (Fig. 7). The digital model was processed to maintain high geometric fidelity while optimizing performance, allowing smooth navigation of both interior and exterior spaces.

- Virtually explore the abbey's structural condition as illustrated in Fig. 7. By integrating the photogrammetric mesh with the semantically enriched BIM structure, users are able to examine wall deformations, material losses, and spatial relationships between load-bearing elements. Within the VR environment, it was possible to switch between multiple Levels of Detail (LOD), supporting both macro-scale assessment of the overall geometry and micro-scale inspection of architectural details.
- Interact with restoration plans and assess the feasibility of different interventions. The combination of BIM models with Unreal Engine simulations allowed real-time testing of conservation scenarios—from reconstructing missing components to analysing the

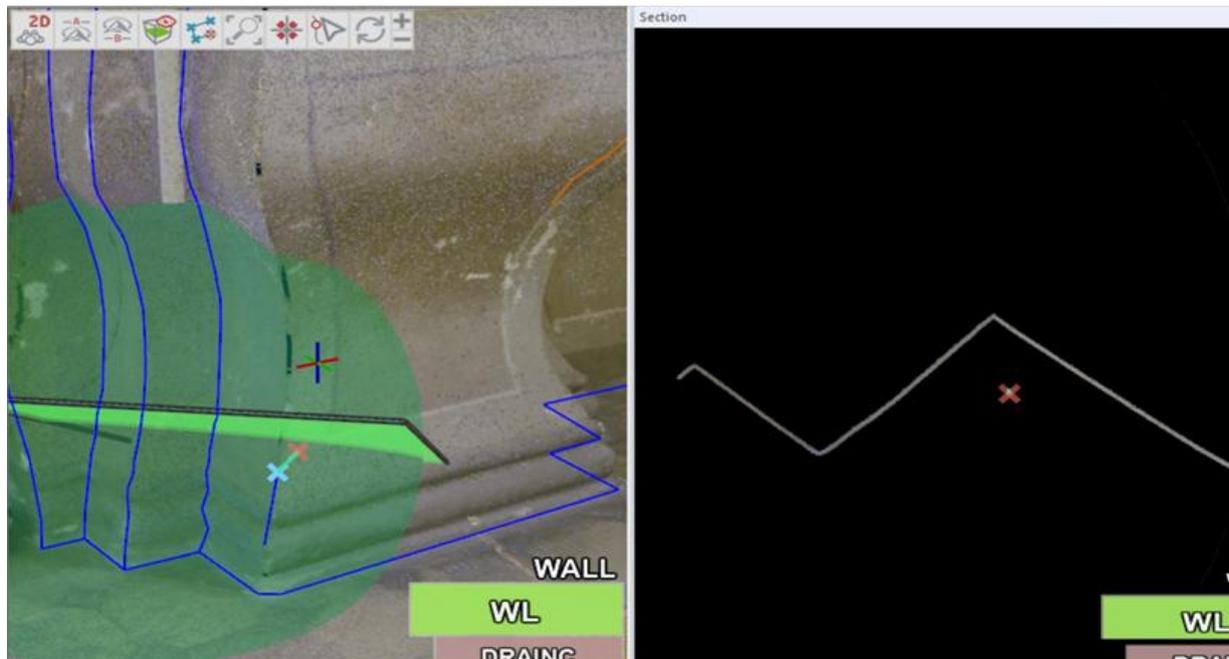
Fig.8 A wall geometry in the building structure (own elaboration)

Extraction of 3D lines from N4CE was the subsequent vital step after data importation to establish wall boundary definitions. Toward wall edge extraction in N4CE the "Pick Point" tool was operated as shown in Figure 5. The extraction process enabled the generation of 3D lines which revealed the exact wall geometry in the building structure (Fig. 8).

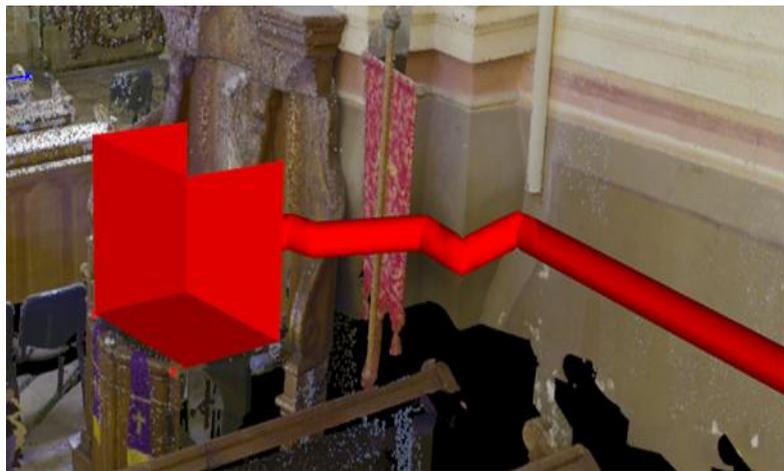
Fig. 9 BIM Model for proposed fire hydrant system (own elaboration)

To strengthen safety precautions for the historic building, a fire hydrant system was created and incorporated into the BIM model as shown in Fig. 9 (in this particular case, it would be necessary to place the confessional in a slightly different location). As part of the fire safety plan, escape routes are analyzed to make sure they are structurally sound and properly designated. The viability of incorporating contemporary early-warning systems without sacrificing the building's historic integrity was also evaluated by modeling sensor-based fire detection systems in BIM. Using the Abbey's digital counterpart, simulations were run to assess fire evacuation scenarios and identify the safest and most effective ways for residents to evacuate. Modern suppression techniques, including misting systems, which effectively control fires while reducing damage to the structure's fragile materials, are also taken into account by the system. This all-encompassing strategy, which combines fire mitigation techniques with BIM-based risk assessment, greatly improves the safety of both people and the cultural site.
